Environmental Defense Institute

by Dave McCoy and Chuck Broschious

Complaint to ID Governor on Mackay Dam Hazards Ignored

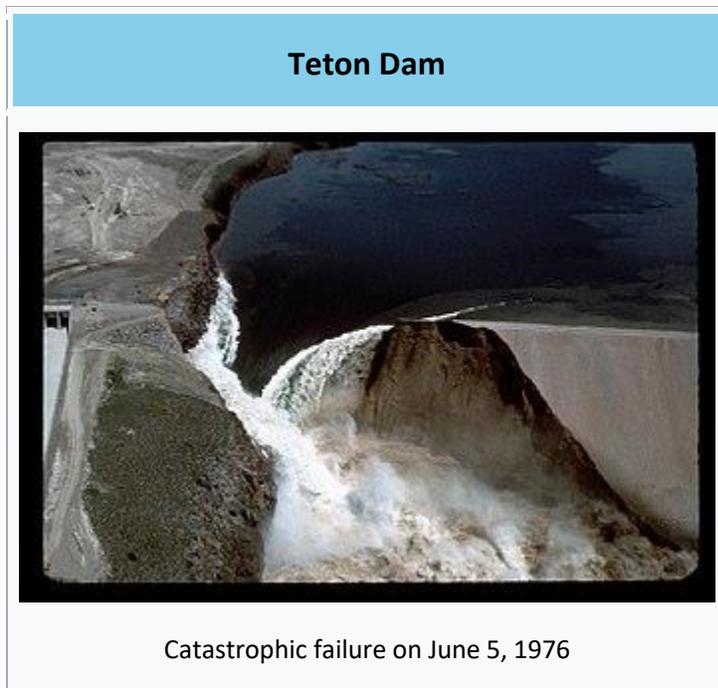
“The **Teton Dam** was an [earthen dam](#) on the [Teton River](#) in [Idaho](#), United States. It was built by the [Bureau of Reclamation](#), one of eight [federal agencies](#) authorized to construct dams.^[3] Located in the [eastern part](#) of the state, between [Fremont](#) and [Madison](#) counties, it suffered a catastrophic failure on June 5, 1976, as it was filling for the first time.

“The collapse of the dam resulted in the deaths of 11 people^[4] and 13,000 cattle. The dam cost about \$100 million to build and the federal government paid over \$300 million in claims related to its failure. Total damage estimates have ranged up to \$2 billion.^[5] The dam has not been rebuilt.” https://en.wikipedia.org/wiki/Teton_Dam#cite_note-bor-4
