Mackay Dam: Failure Far More Likely Than Previously Thought

Environmental Defense Institute

Tami Thatcher

September 2, 2022

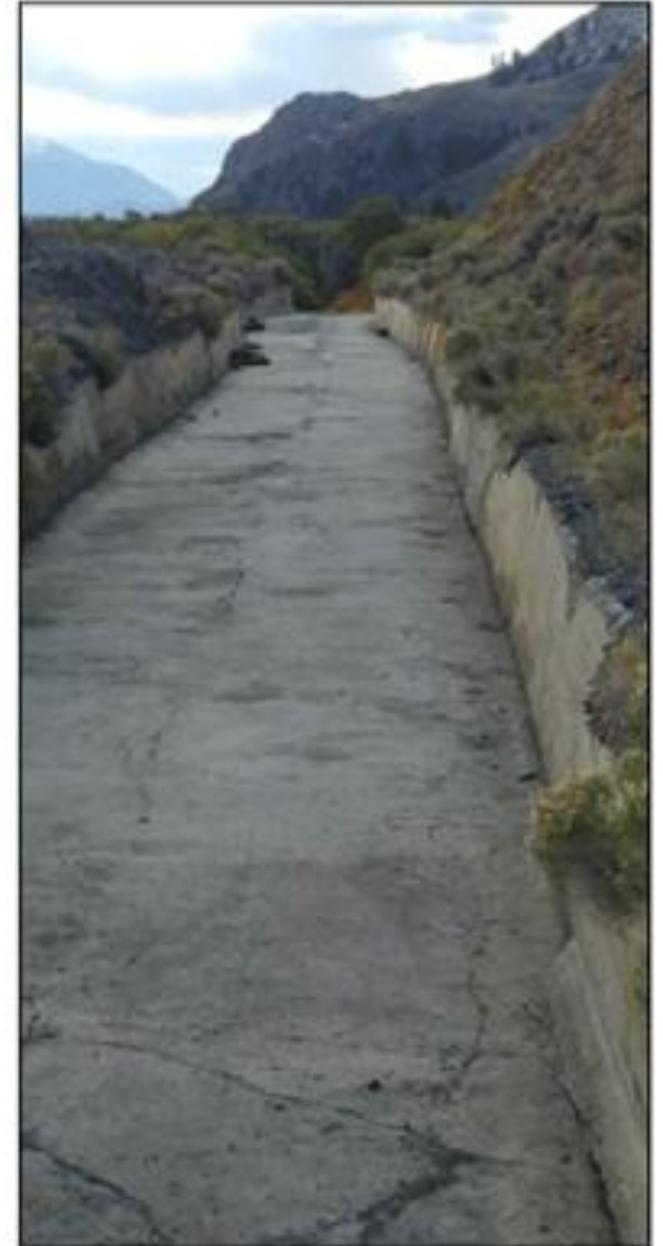
Spillway concrete deterioration

- The spillway was never of adequate width.
- The spillway crosses over the embankment
- The spillway crosses over the outlet tunnel.
- The spillway experiences rockfall.
- The spillway walls are cracked and buckling.

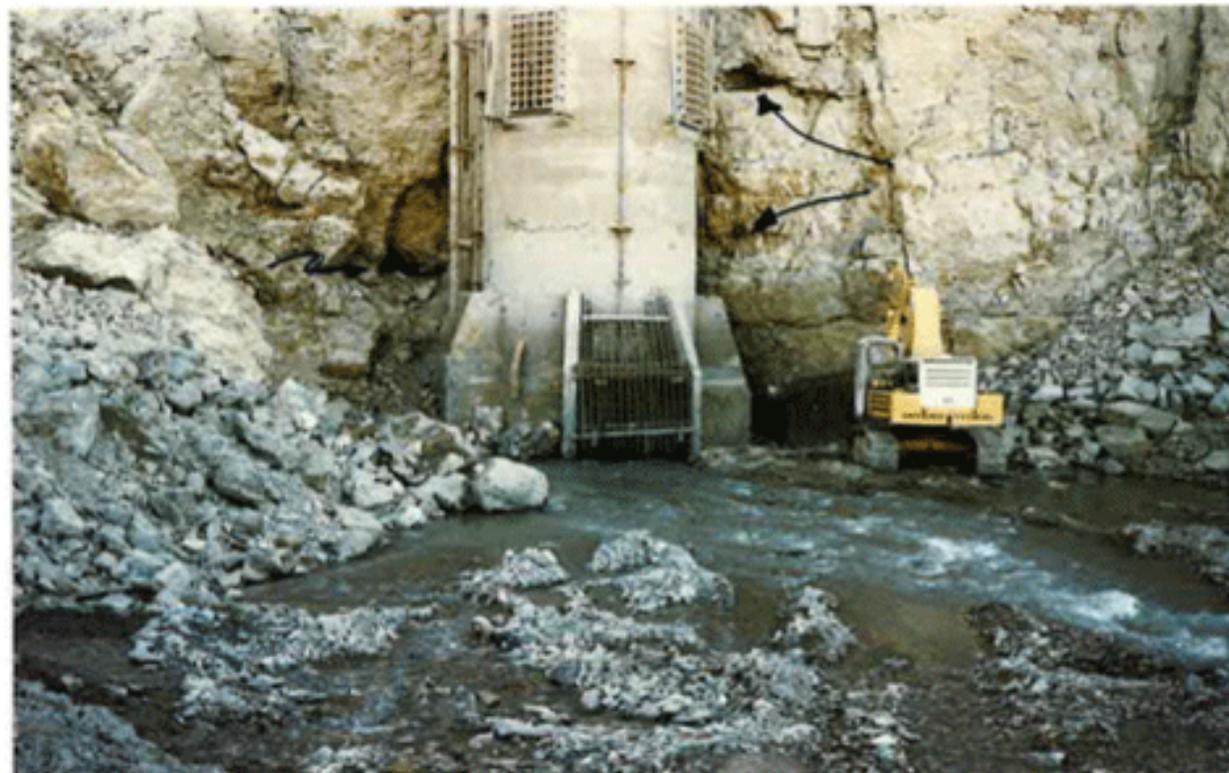
MACKAY DAM
34-2225
October 29, 1985

The Outlet Tower is vulnerable to rock fall

Backhoe has Removed Rock and Debris from Gate. Gate on Right has a Bent Stem:

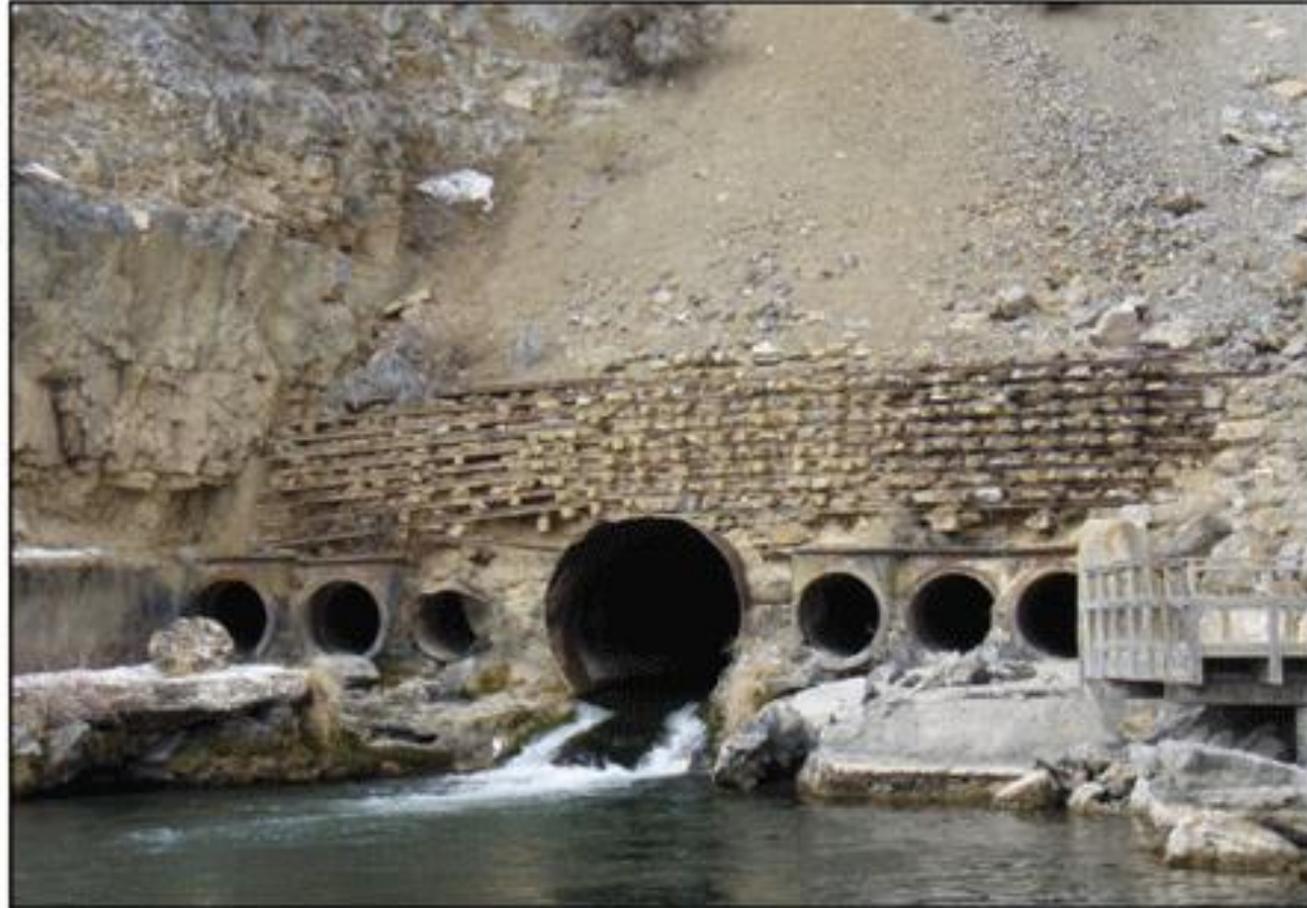
The outlet tunnel apron is deteriorating

Photo 3b (3/27/2013) – Similar view of the tunnel outfall at low flow conditions.

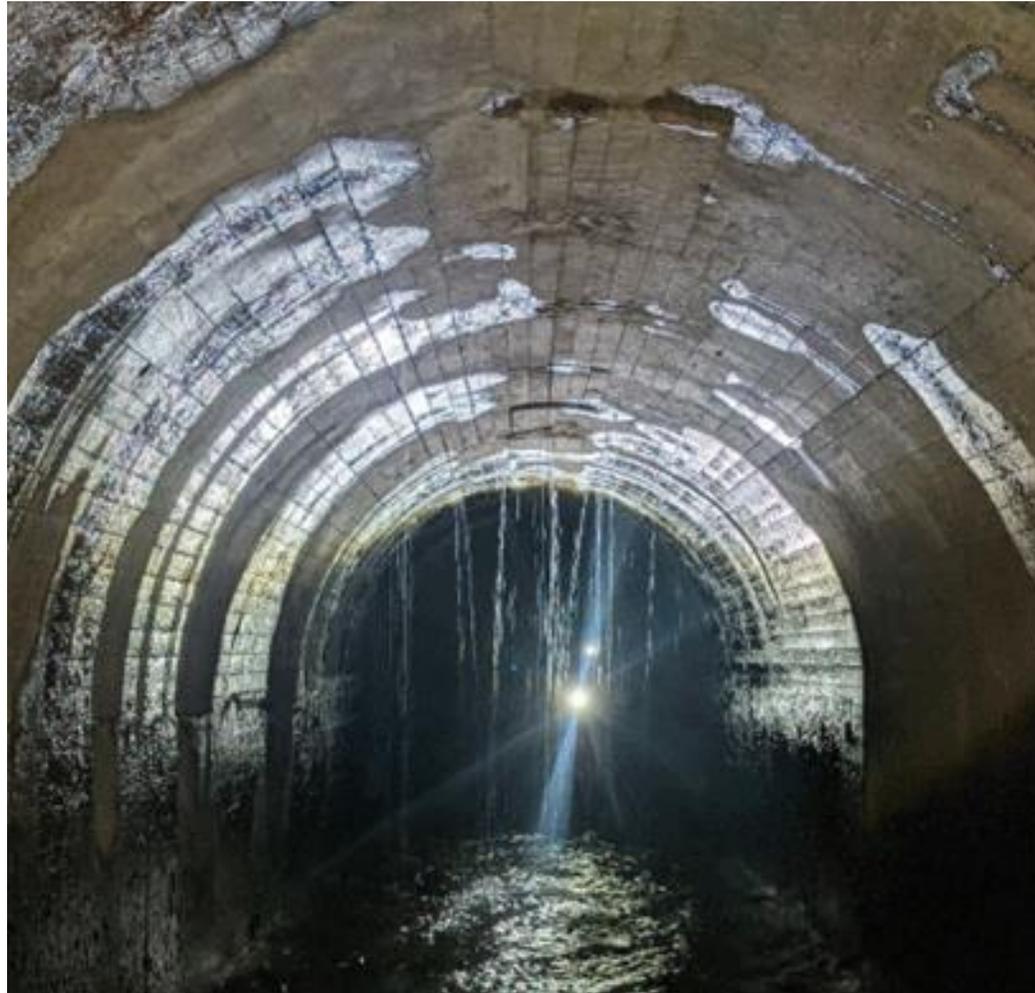
The outlet tunnel is deteriorating

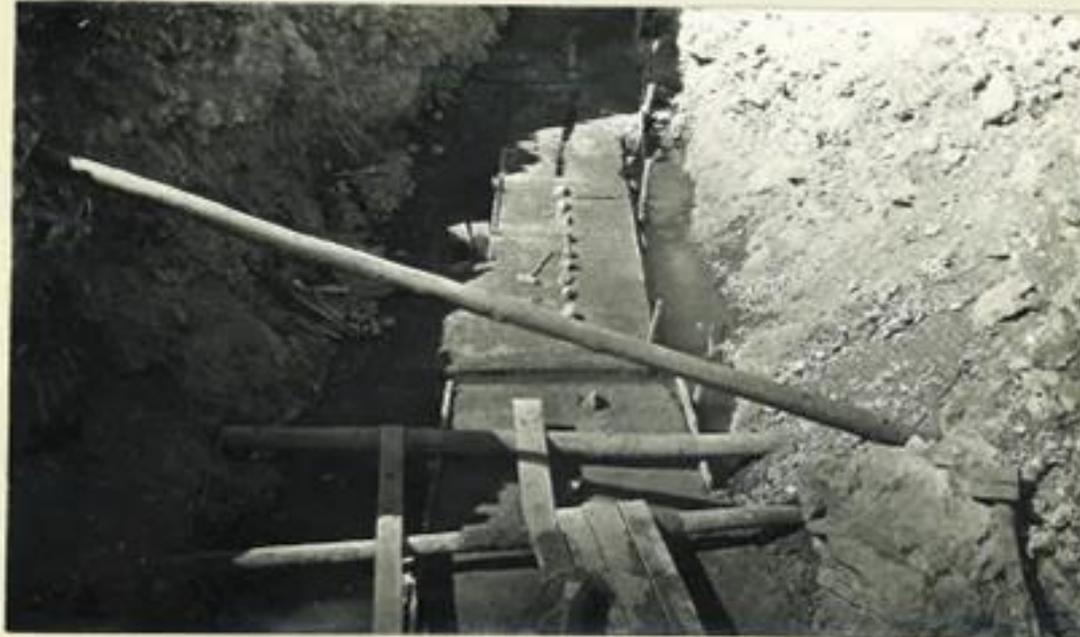
The concrete core wall is of partial height and inadequate design and construction. The sandy gravel fill was not compacted.

No. 2 shows the foundation course for the core wall being placed,
