# Environmental Defense Institute

September 2022

### Mackay Dam Failure, Far More Likely Than Previously Thought – No Apparent Action by State and Federal Agencies

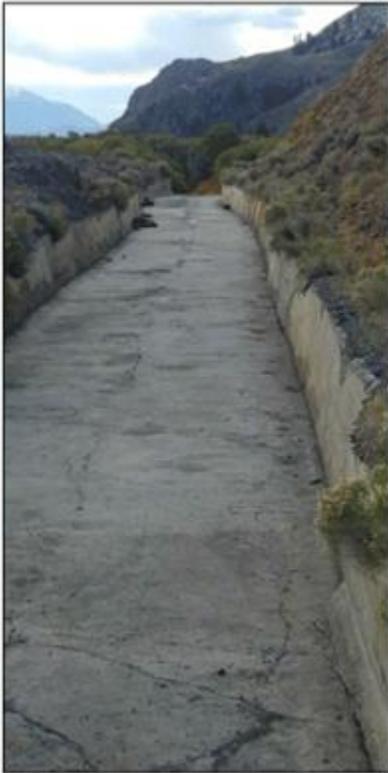
As part of the effort to develop possible design alternatives for Mackay Dam rehabilitation, McMillen Jacobs prepared an analysis of the Potential Failure Mode Analysis and Risk Assessment and a meeting was held in 2020. This later become Appendix F of the 2021 report.<sup>9</sup> Appendix F identified spillway flow capacity below what had been estimated in a 1986 study for the Department of Energy.<sup>10</sup> **The value for spillway capacity in Appendix F was recognized at only 2,200 cfs whereas the 1986 report had estimated the spillway capacity as being 6,588 cfs. The 1986 estimate had apparently evaluated the flow capacity at the crest of the spillway but had not considered flow restrictions further downstream of the spillway that limit the flow capability.**

The total outlet tunnel plus spillway release capability were estimated as 3010 cfs (outlet) plus 2,200 cfs (spillway) for a combined release capability of 5210 cfs in the 2021 Appendix F by McMillen Jacobs. The total outlet tunnel plus spillway release capability estimated in the 1986 report were far higher at 2,960 cfs (outlet) plus 6588 cfs (spillway), or a combined release capability of 9598 cfs.

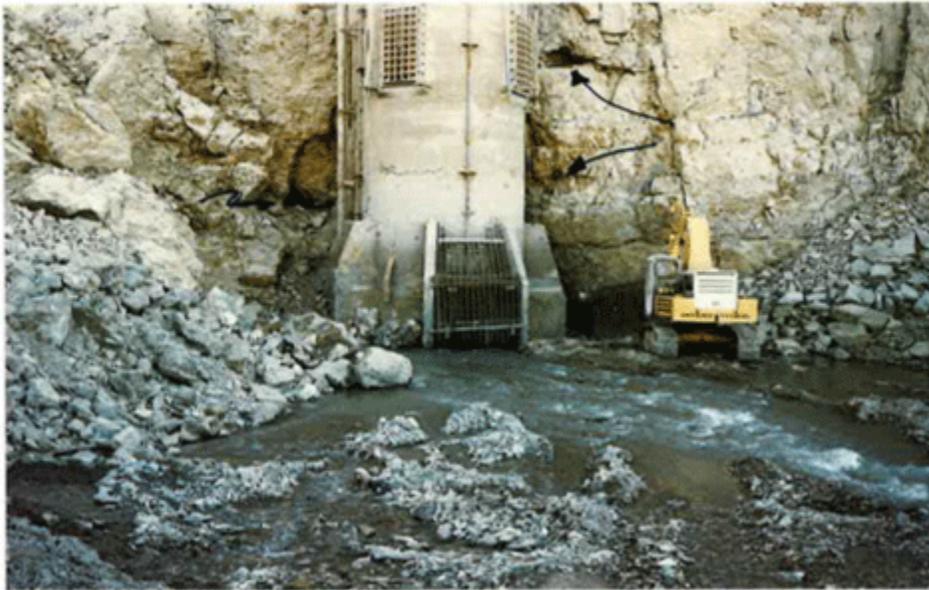
MACKAY DAM  
34-2225  
October 29, 1985

Backhoe has Removed Rock and Debris from Gate. Gate on Right has a Bent Stem:

No work to address the overhanging rock cliffs, as recommended in 1947 and again in 1978, was conducted until after the Borah Peak earthquake in 1983 which dislodged considerable rock fall into the spillway (and also turned leakage from the dam to a milky white). When the work was conducted in 1984, it apparently caused rock fall into the reservoir around the outlet tower, which was then addressed in 1985 at the outlet tower with the reservoir drained.

Pictures are available of the work conducted in November of 1984 by blasting the rock cliff over the spillway, and in October 1985, to remove extensive fallen rock from near the outlet control tower. **It remains officially undocumented as to whether the 1983 Borah earthquake or the blasting of rock cliffs over the spillway caused the extensive fallen rock near the outlet tunnel.** Inspection of the dam after the 1983 Borah earthquake did not identify fallen rock affecting the outlet gates and so it would seem that the rock blasting of the cliffs over the

spillway in 1984 caused considerable rock fall around the outlet control tower. Rock fall remains a problem that could partially block the lower outlet gate entrances.

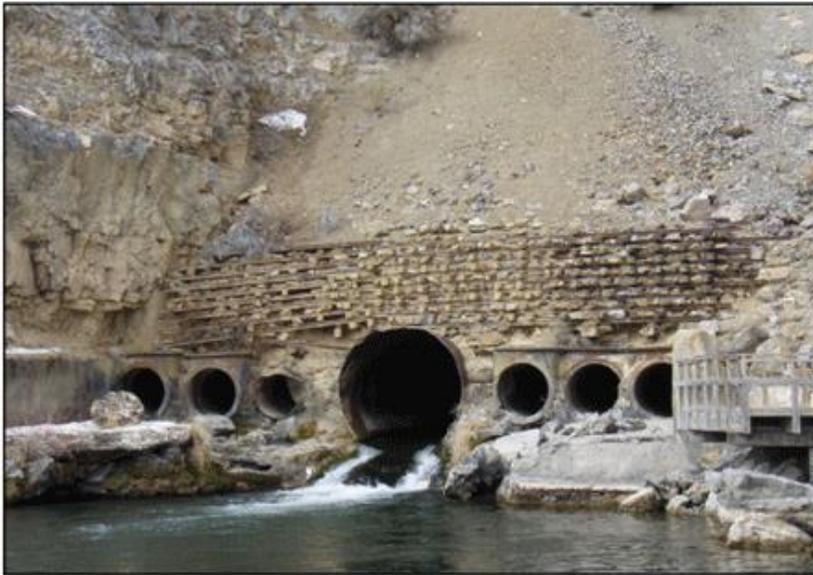
The outlet tunnel is concrete lined for most of the tunnel. The outlet tunnel at the toe of the dam is metal pipe surrounded by rather loose fill. The timber and rail apron about the outlet of the tunnel are deteriorating. Tons of loose rock are above the apron. Rock cliffs are to the side of the outlet, beneath the spillway.

Photo 3b (3/27/2013) – Similar view of the tunnel outfall at low flow conditions.

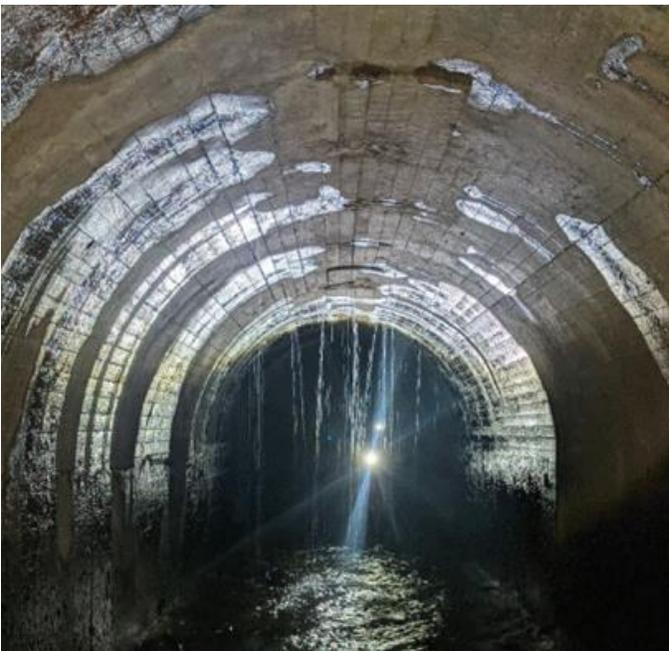
**In 2007, the condition of the embankment, outlet works and spillway were rated as “good”; by 2011 all were rated as “fair”; by 2017, the outlet and spillway are both being rated as “poor.”**
