The Truth about the SL-1 Accident — Understanding the Reactor Excursion and Safety Problems at SL-1

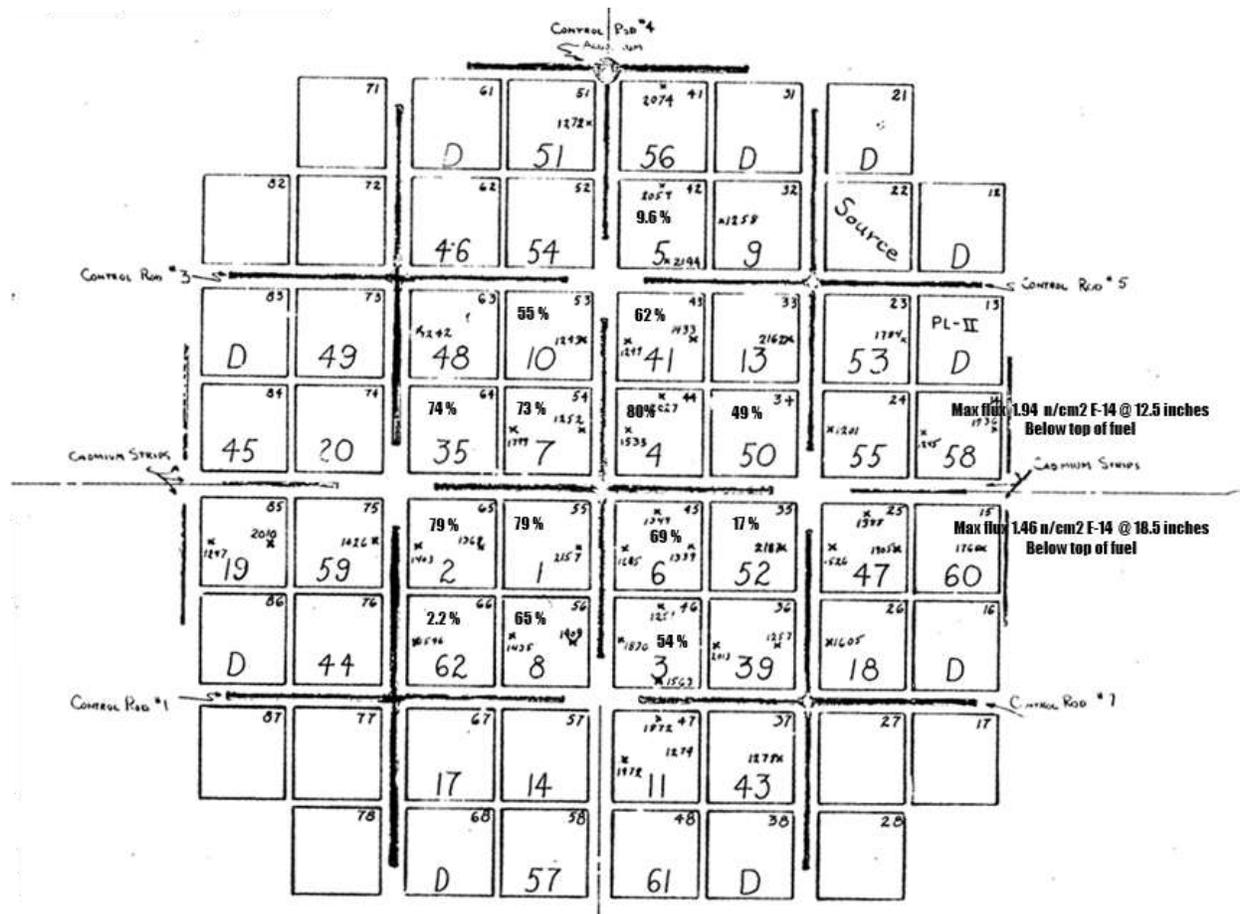
Although this would not have caused the accident, it is identified in the post-accident examination of the core that on the east side of the core, the east position at control tee-position 6, where three cadmium strips were installed, that one of the three strips was found 2 ½ inches below the proper position. That this was a pre-accident core loading mistake is not discussed. However, the consequences of this mispositioning are suggested by the distribution of damage in the core.¹² See Figure 2.

Even with the two instead of four cadmium shim locations, one would have expected the north and south fuel assembly powers of the core to be symmetrical: they were not. The effect of mispositioning one of cadmium shims, with its three strips filling the tee slots on the east side of the reactor can be seen in the higher power of the fuel assembly, No. 58 during the accident, next to what I presume is the mispositioned shim. Fuel assembly No. 58 has a higher power, peaking at a higher elevation in the core, than the fuel assembly south of it, fuel assembly No. 60.^{13 14}

Figure 2. SL-1 fuel assemblies, core positions, and percent destroyed, i.e. just northwest of center, fuel assembly 7 in position 54 has 73% of the fuel destroyed. Adapted from IDO-19311, figure III-89.

assembly No. 1) which had only 253 MWD of burnup.¹⁵ This made it a higher power fuel assembly, generating more neutrons and increasing its power level and that of its neighboring fuel assemblies during the accident. The higher fuel plate powers generated in the south-west portion of the center of the core can be seen by comparing fuel powers achieved during the accident of fuel assemblies 2 and 52. Fuel assembly 2 was 79 percent destroyed during the accident, while the symmetrically positioned fuel assembly No. 52 was only 17 percent destroyed.¹⁶

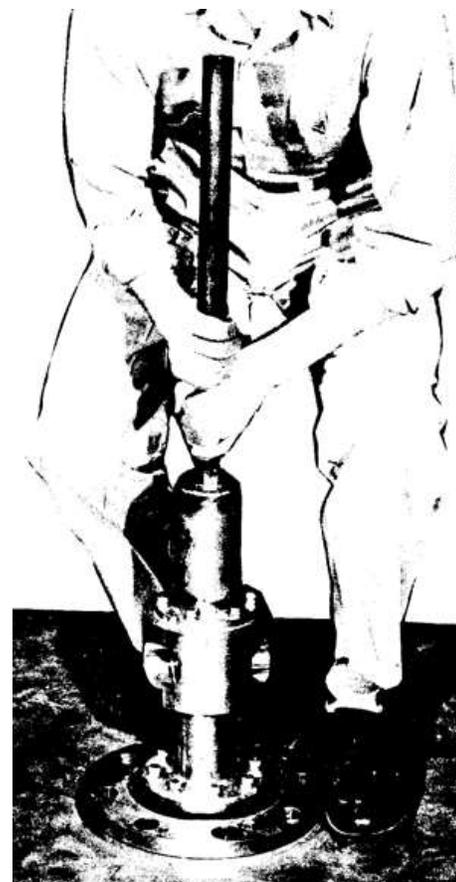
The results of the control rod mock-ups for measuring the distance of rod travel and the speed of travel are documented in a table and figure. The finding was that a casual effort as well as a maximum effort in lifting the control rod achieved adequate speed for the prompt criticality condition and that there would be no time for correcting an overlift because it would occur in less than a third of a second.³²

The control rod initial position would still have remained the 2 to 3 inches above the normal scram position. This left an additional 17 to 18 inches to reach the as-found control rod blade withdrawal position. A possible ½ inch of rod movement during the excursion was acknowledged as possible and the 20-inch withdrawal distance uncertainty was plus or minus ½ inch. So, jerking the center control rod if it did not move freely, an over-travel of as little as 16 inches in less than a third of a second was all that was needed for the accident to take place. See Figure 3.

Figure 3. Mock-up of manual rod lift from IDO-19300.
