The Truth about the SL-1 Accident — Understanding the Reactor Excursion and Safety Problems at SL-1

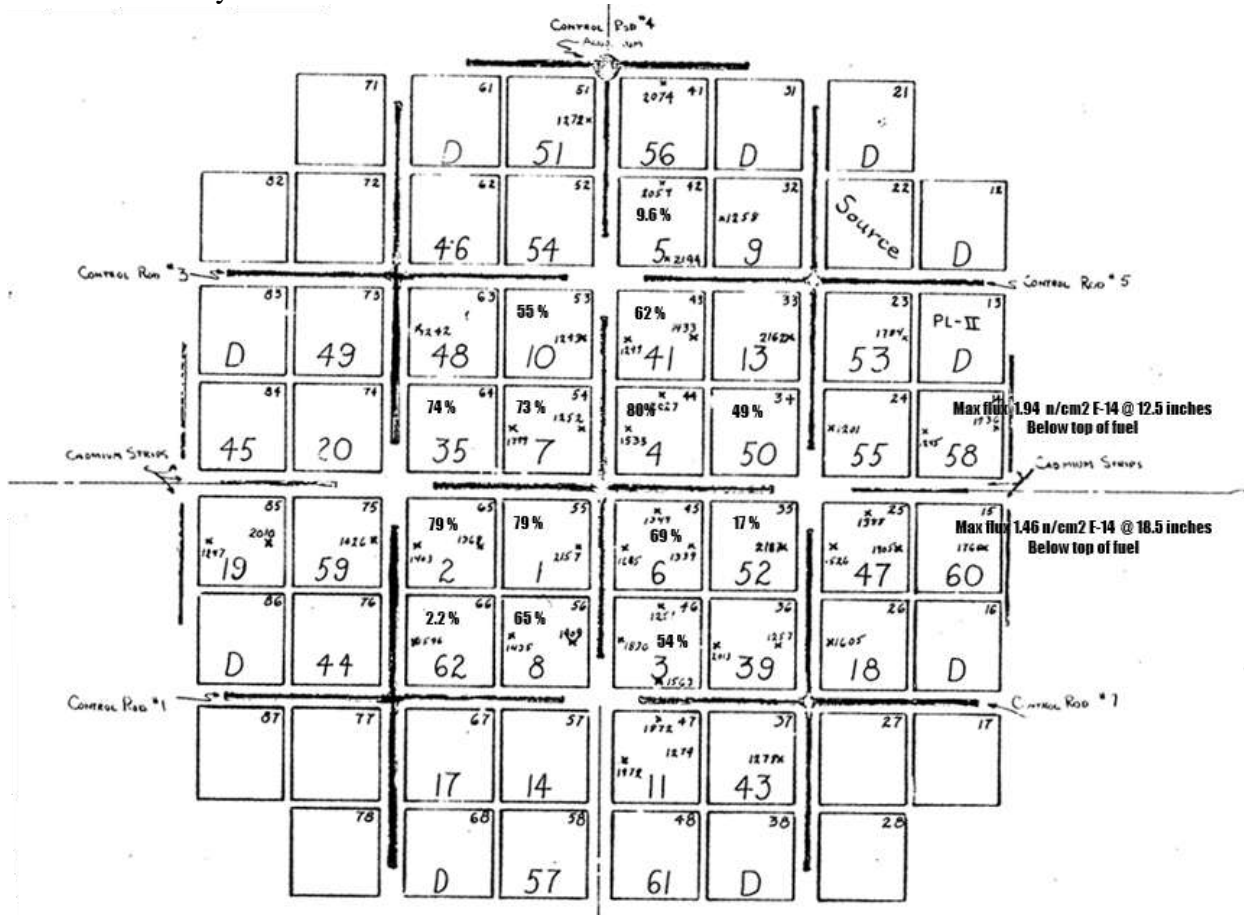
Although this would not have caused the accident, it is identified in the post-accident examination of the core that on the east side of the core, the east position at control tee-position 6, where three cadmium strips were installed, that one of the three strips was found 2 ½ inches below the proper position. That this was a pre-accident core loading mistake is not discussed. However, the consequences of this mispositioning are suggested by the distribution of damage in the core.¹² See Figure 2.

The choice to put the cadmium strips in the #2 and 6 tee positions (which can pictorially be thought of as east and west positions, see Figure 2) while providing sorely needed additional shutdown margin had the effect of reducing power on the east and west sides, but of increasing reactor power on the north and south sides of the reactor. After their installation, reactor operating power oscillations had increased. The power levels and fuel damage from the accident are highest in the central area of the core. But fuel plate powers were higher in the north and south than the east and west because of the two rather than four cadmium shim positions used.

mispositioning one of cadmium shims, with its three strips filling the tee slots on the east side of the reactor can be seen in the higher power of the fuel assembly, No. 58 during the accident, next to what I presume is the mispositioned shim. Fuel assembly No. 58 has a higher power, peaking at a higher elevation in the core, than the fuel assembly south of it, fuel assembly No. 60.^{13 14}

Figure 2. SL-1 fuel assemblies, core positions, and percent destroyed, i.e. just northwest of center, fuel assembly 7 in position 54 has 73% of the fuel destroyed. Adapted from IDO-19311, figure III-89.

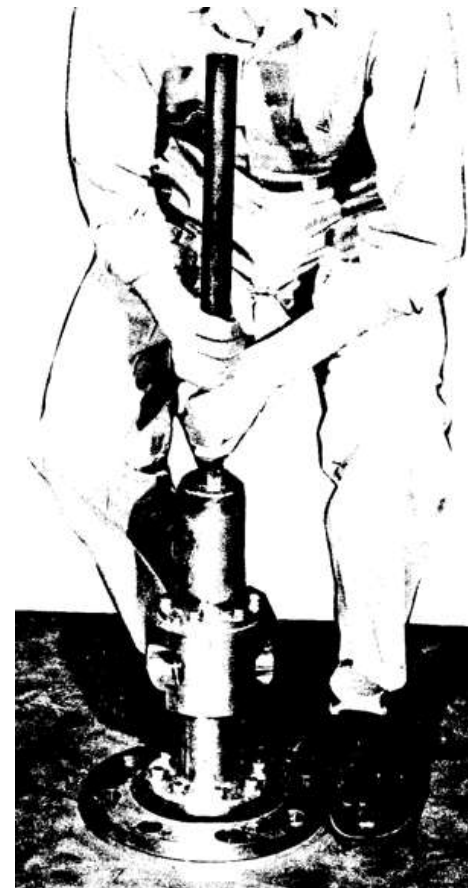
The control rod initial position would still have remained the 2 to 3 inches above the normal scram position. This left an additional 17 to 18 inches to reach the as-found control rod blade withdrawal position. A possible ½ inch of rod movement during the excursion was acknowledged as possible and the 20 inch withdrawal distance uncertainty was plus or minus ½ inch. So jerking the center control rod if it did not move freely, an over-travel of as little as 16 inches in less than a third of a second was all that was needed for the accident to take place. See Figure 3.

Figure 3. Mock-up of manual rod lift from IDO-19300.
