The Truth about the SL-1 Accident — Understanding the Reactor Excursion and Safety Problems at SL-1

Key Things to Remember About What Caused The SL-1 Accident:

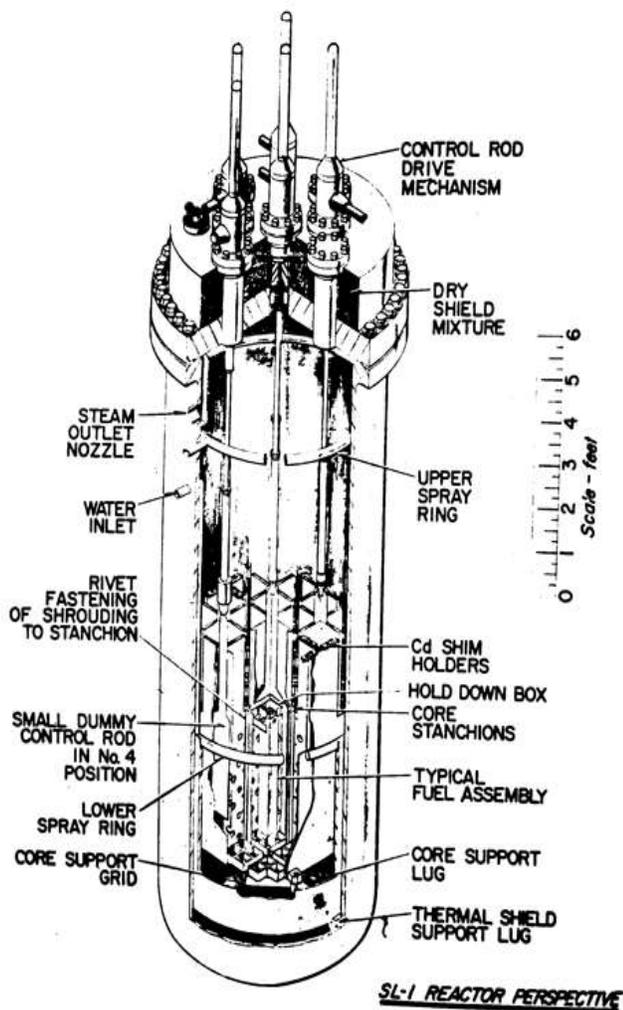
The SL-1 core contained 14 kg of 93 percent enriched Uranium-235 in 40 aluminum fuel assemblies. Control of the reactor used 5 cruciform-shaped cadmium control blades raised and lowered by control rods. There were 4 outer (shim) control rods, labeled No. 1, 3, 5 and 7, and one center control rod, No. 9, to regulate reactor power. In addition to the control rods, burnable poison was added in the form of aluminum-boron strips, both half length and fuel length, that were spot welded to the sides of the fuel assemblies. See Figure 1.

Figure 1. SL-1 Reactor perspective from IDO-19311.

680 MWD. The boron strips were deteriorating and bowing of the strips made removal of fuel assemblies difficult; therefore, fuel inspections simply ceased.²

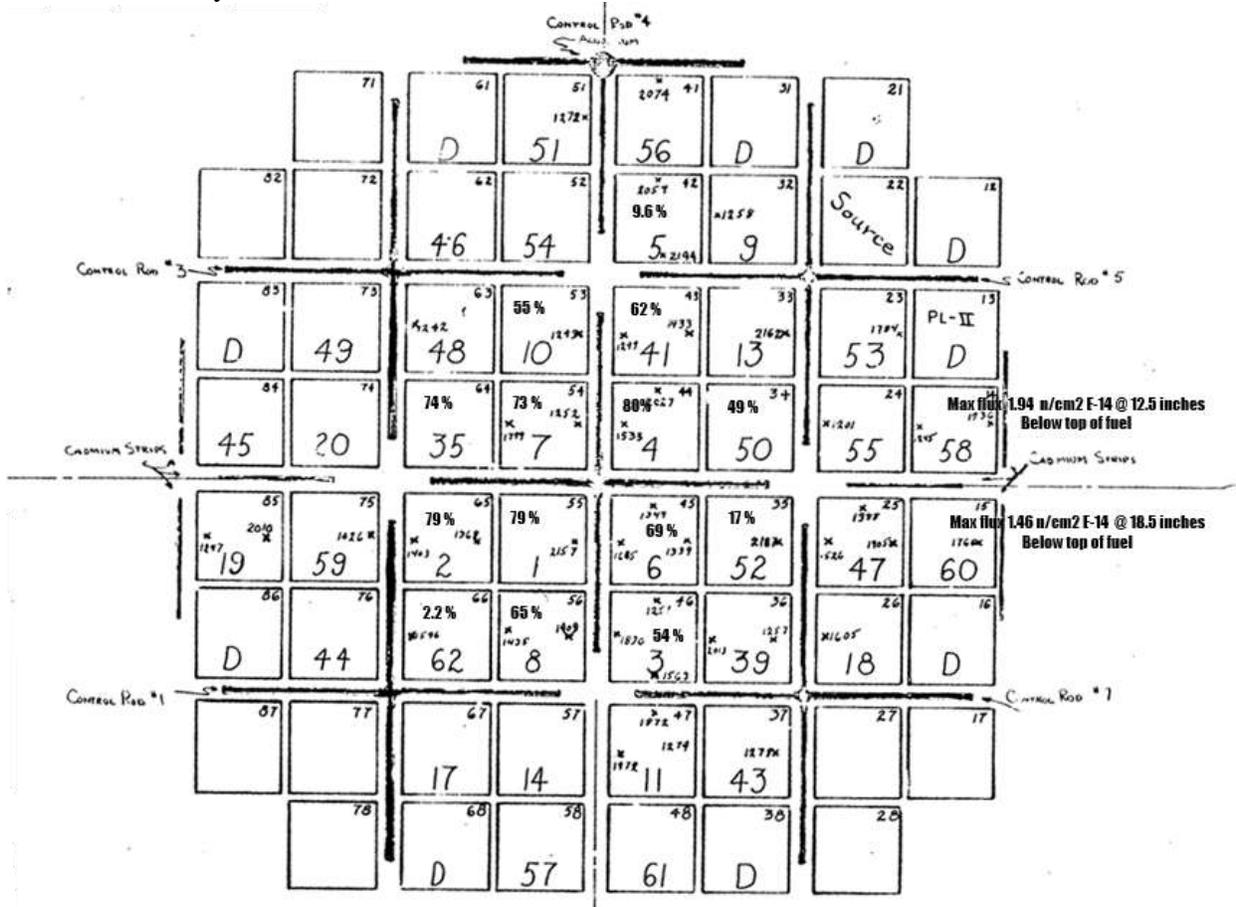
Although this would not have caused the accident, it is identified in the post-accident examination of the core that on the east side of the core, the east position at control tee-position 6, where three cadmium strips were installed, that one of the three strips was found 2 ½ inches below the proper position. That this was a pre-accident core loading mistake is not discussed. However, the consequences of this mispositioning are suggested by the distribution of damage in the core.¹² See Figure 2.

The choice to put the cadmium strips in the #2 and 6 tee positions (which can pictorially be thought of as east and west positions, see Figure 2) while providing sorely needed additional shutdown margin had the effect of reducing power on the east and west sides, but of increasing reactor power on the north and south sides of the reactor. After their installation, reactor operating power oscillations had increased. The power levels and fuel damage from the accident are highest in the central area of the core. But fuel plate powers were higher in the north and south than the east and west because of the two rather than four cadmium shim positions used.

mispositioning one of cadmium shims, with its three strips filling the tee slots on the east side of the reactor can be seen in the higher power of the fuel assembly, No. 58 during the accident, next to what I presume is the mispositioned shim. Fuel assembly No. 58 has a higher power, peaking at a higher elevation in the core, than the fuel assembly south of it, fuel assembly No. 60.^{13 14}

Figure 2. SL-1 fuel assemblies, core positions, and percent destroyed, i.e. just northwest of center, fuel assembly 7 in position 54 has 73% of the fuel destroyed. Adapted from IDO-19311, figure III-89.

There appears to be another problem with core configuration not pointed out in the reports. One of the central fuel assemblies, position 55, had been replaced with fuel assembly (Fuel assembly No. 1) which had only 253 MWD of burnup.¹⁵ This made it a higher power fuel assembly, generating more neutrons and increasing its power level and that of its neighboring fuel assemblies during the accident. The higher fuel plate powers generated in the south-west portion of the center of the core can be seen by comparing fuel powers achieved during the accident of fuel assemblies 2 and 52. Fuel assembly 2 was 79 percent destroyed during the

accident, while the symmetrically positioned fuel assembly No. 52 was only 17 percent destroyed.¹⁶

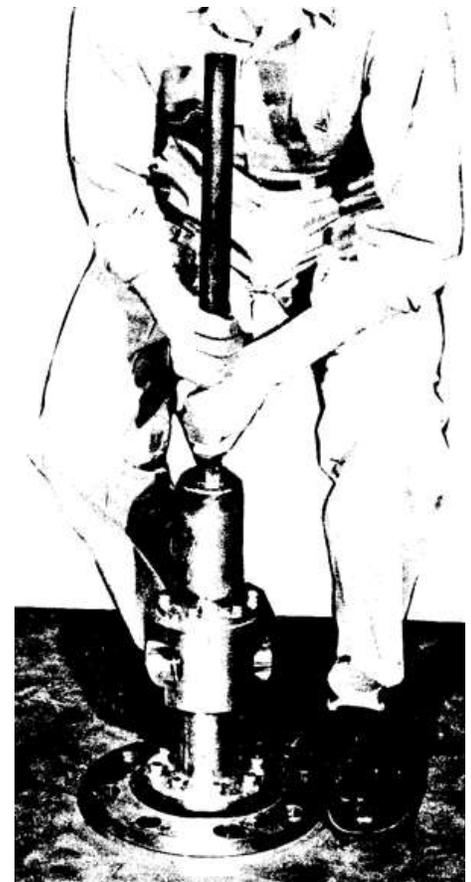
The results of the control rod mock-ups for measuring the distance of rod travel and the speed of travel are documented in a table and figure. The finding was that a casual effort as well as a maximum effort in lifting the control rod achieved adequate speed for the prompt criticality condition and that there would be no time for correcting an overlift because it would occur in less than a third of a second.³²

The control rod initial position would still have remained the 2 to 3 inches above the normal scram position. This left an additional 17 to 18 inches to reach the as-found control rod blade withdrawal position. A possible ½ inch of rod movement during the excursion was acknowledged as possible and the 20 inch withdrawal distance uncertainty was plus or minus ½ inch. So jerking the center control rod if it did not move freely, an over-travel of as little as 16 inches in less than a third of a second was all that was needed for the accident to take place. See Figure 3.

Figure 3. Mock-up of manual rod lift from IDO-19300.
