The SL-1 Accident Consequences

A Comparison of the Three Mile Island Unit 2 Fuel Release Fractions to the SL-1 Derived Release Fractions

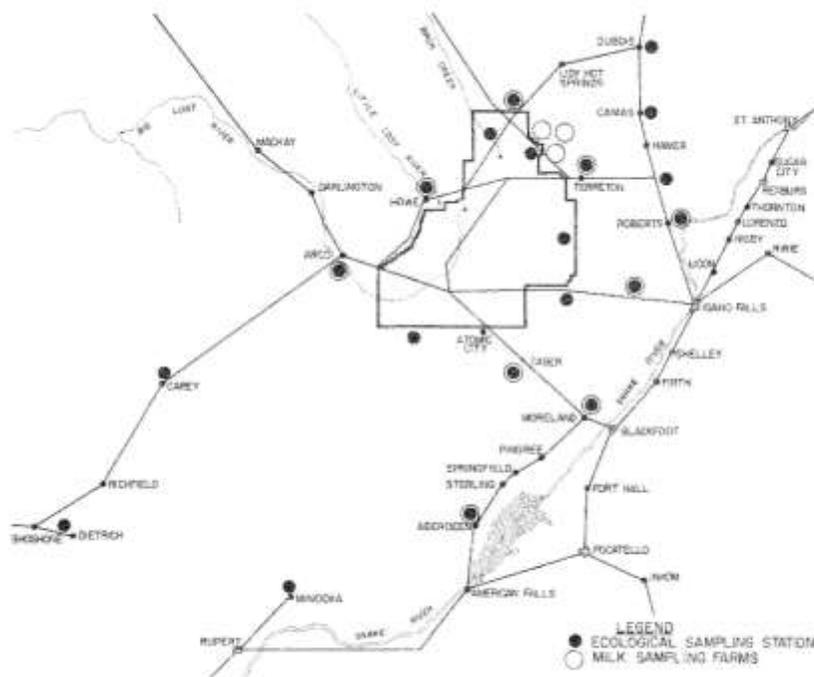
Fig. 51 Perimeter and off-site biological monitoring stations.

It was customary for the AEC to monitor jack rabbit thyroids and the iodine-131 levels before the SL-1 accident, for jack rabbit thyroids were typically 100 picocuries per gram. After the SL-1 accident, the levels were as high as 750,000 picocuries per gram at the SL-1, 180,000 picocuries/gram at nearby Atomic City, located south of the SL-1, and 50,000 picocuries per gram at Tabor, a farming community southeast of SL-1 and west of Blackfoot, and 11,200 picocuries at Springfield. These rabbit thyroid results reveal much higher rabbit thyroid iodine-131 levels than produced by the other large episodic and routine releases from the Idaho National Laboratory during the 1950s and 1960s.^{24 25 26 27}

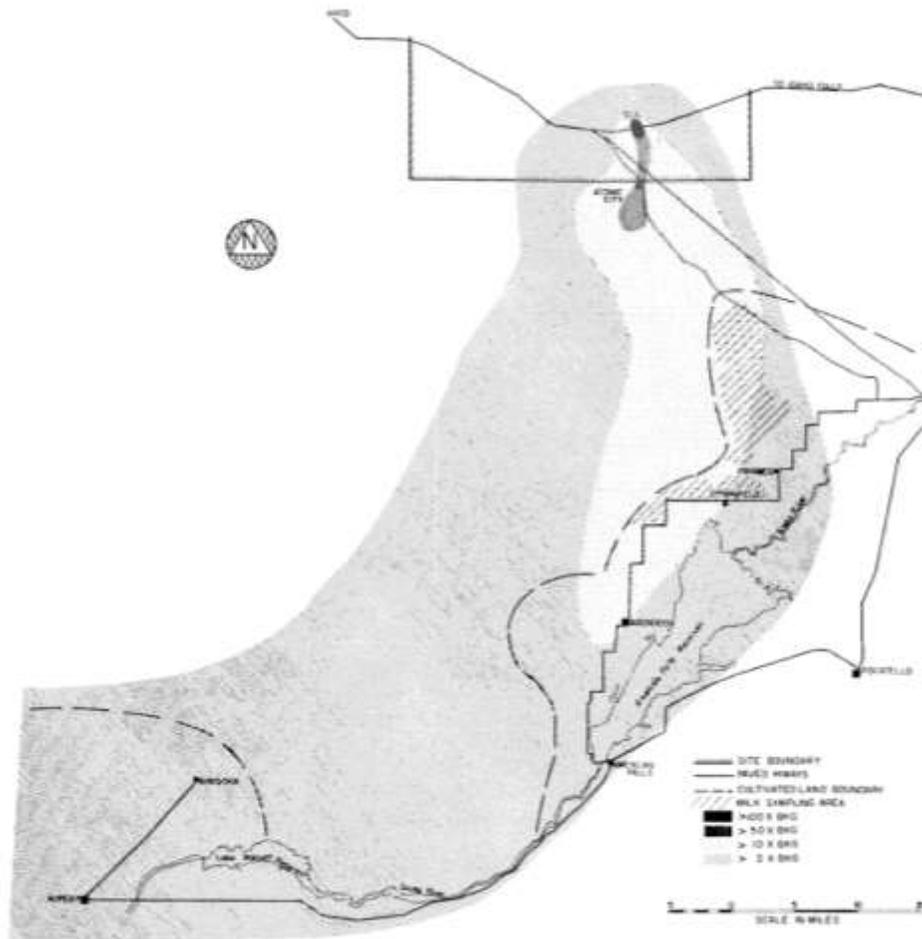
Fig. 52 Iodine-131 deposition on vegetation.

Figure 52, above, depicts the SL-1 radiological plume. The AEC claimed that the radioactive fallout from the SL-1 accident was mainly iodine-131. The AEC's claimed total iodine-131 release from the SL-1 accident would mean that an impossibly low release fraction for the iodine-131 held up the iodine-131 in the fuel. The SL-1 fuel was similar to the Materials Test Reactor fuel, which was not assumed to have low release fractions. The derived low release fractions are predicated on the AEC's stated curie release estimates and the stated curie estimate, along with the AEC's assertion that it was mainly iodine-131 that was released from the SL-1 are simply too good to be true.
