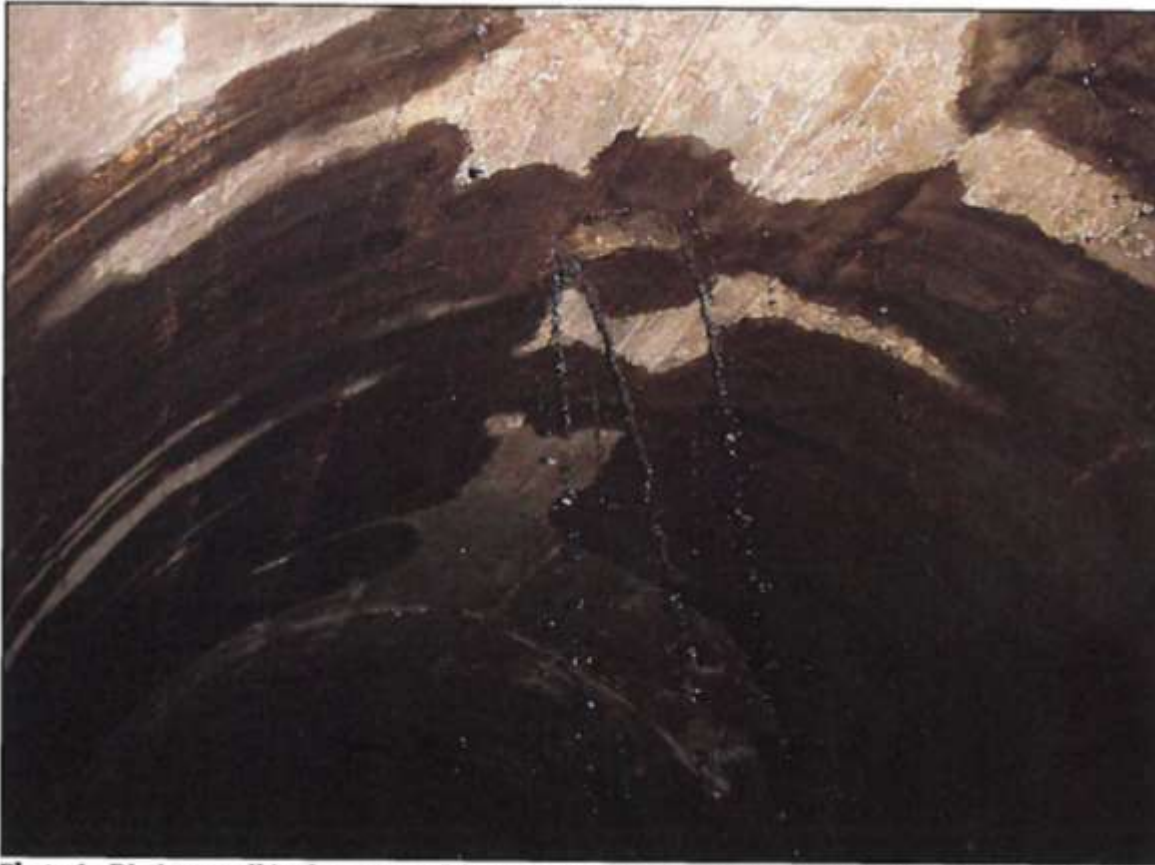
Photo 11 - Typical tunnel appearance showing seeping water and calcified construction joints.
