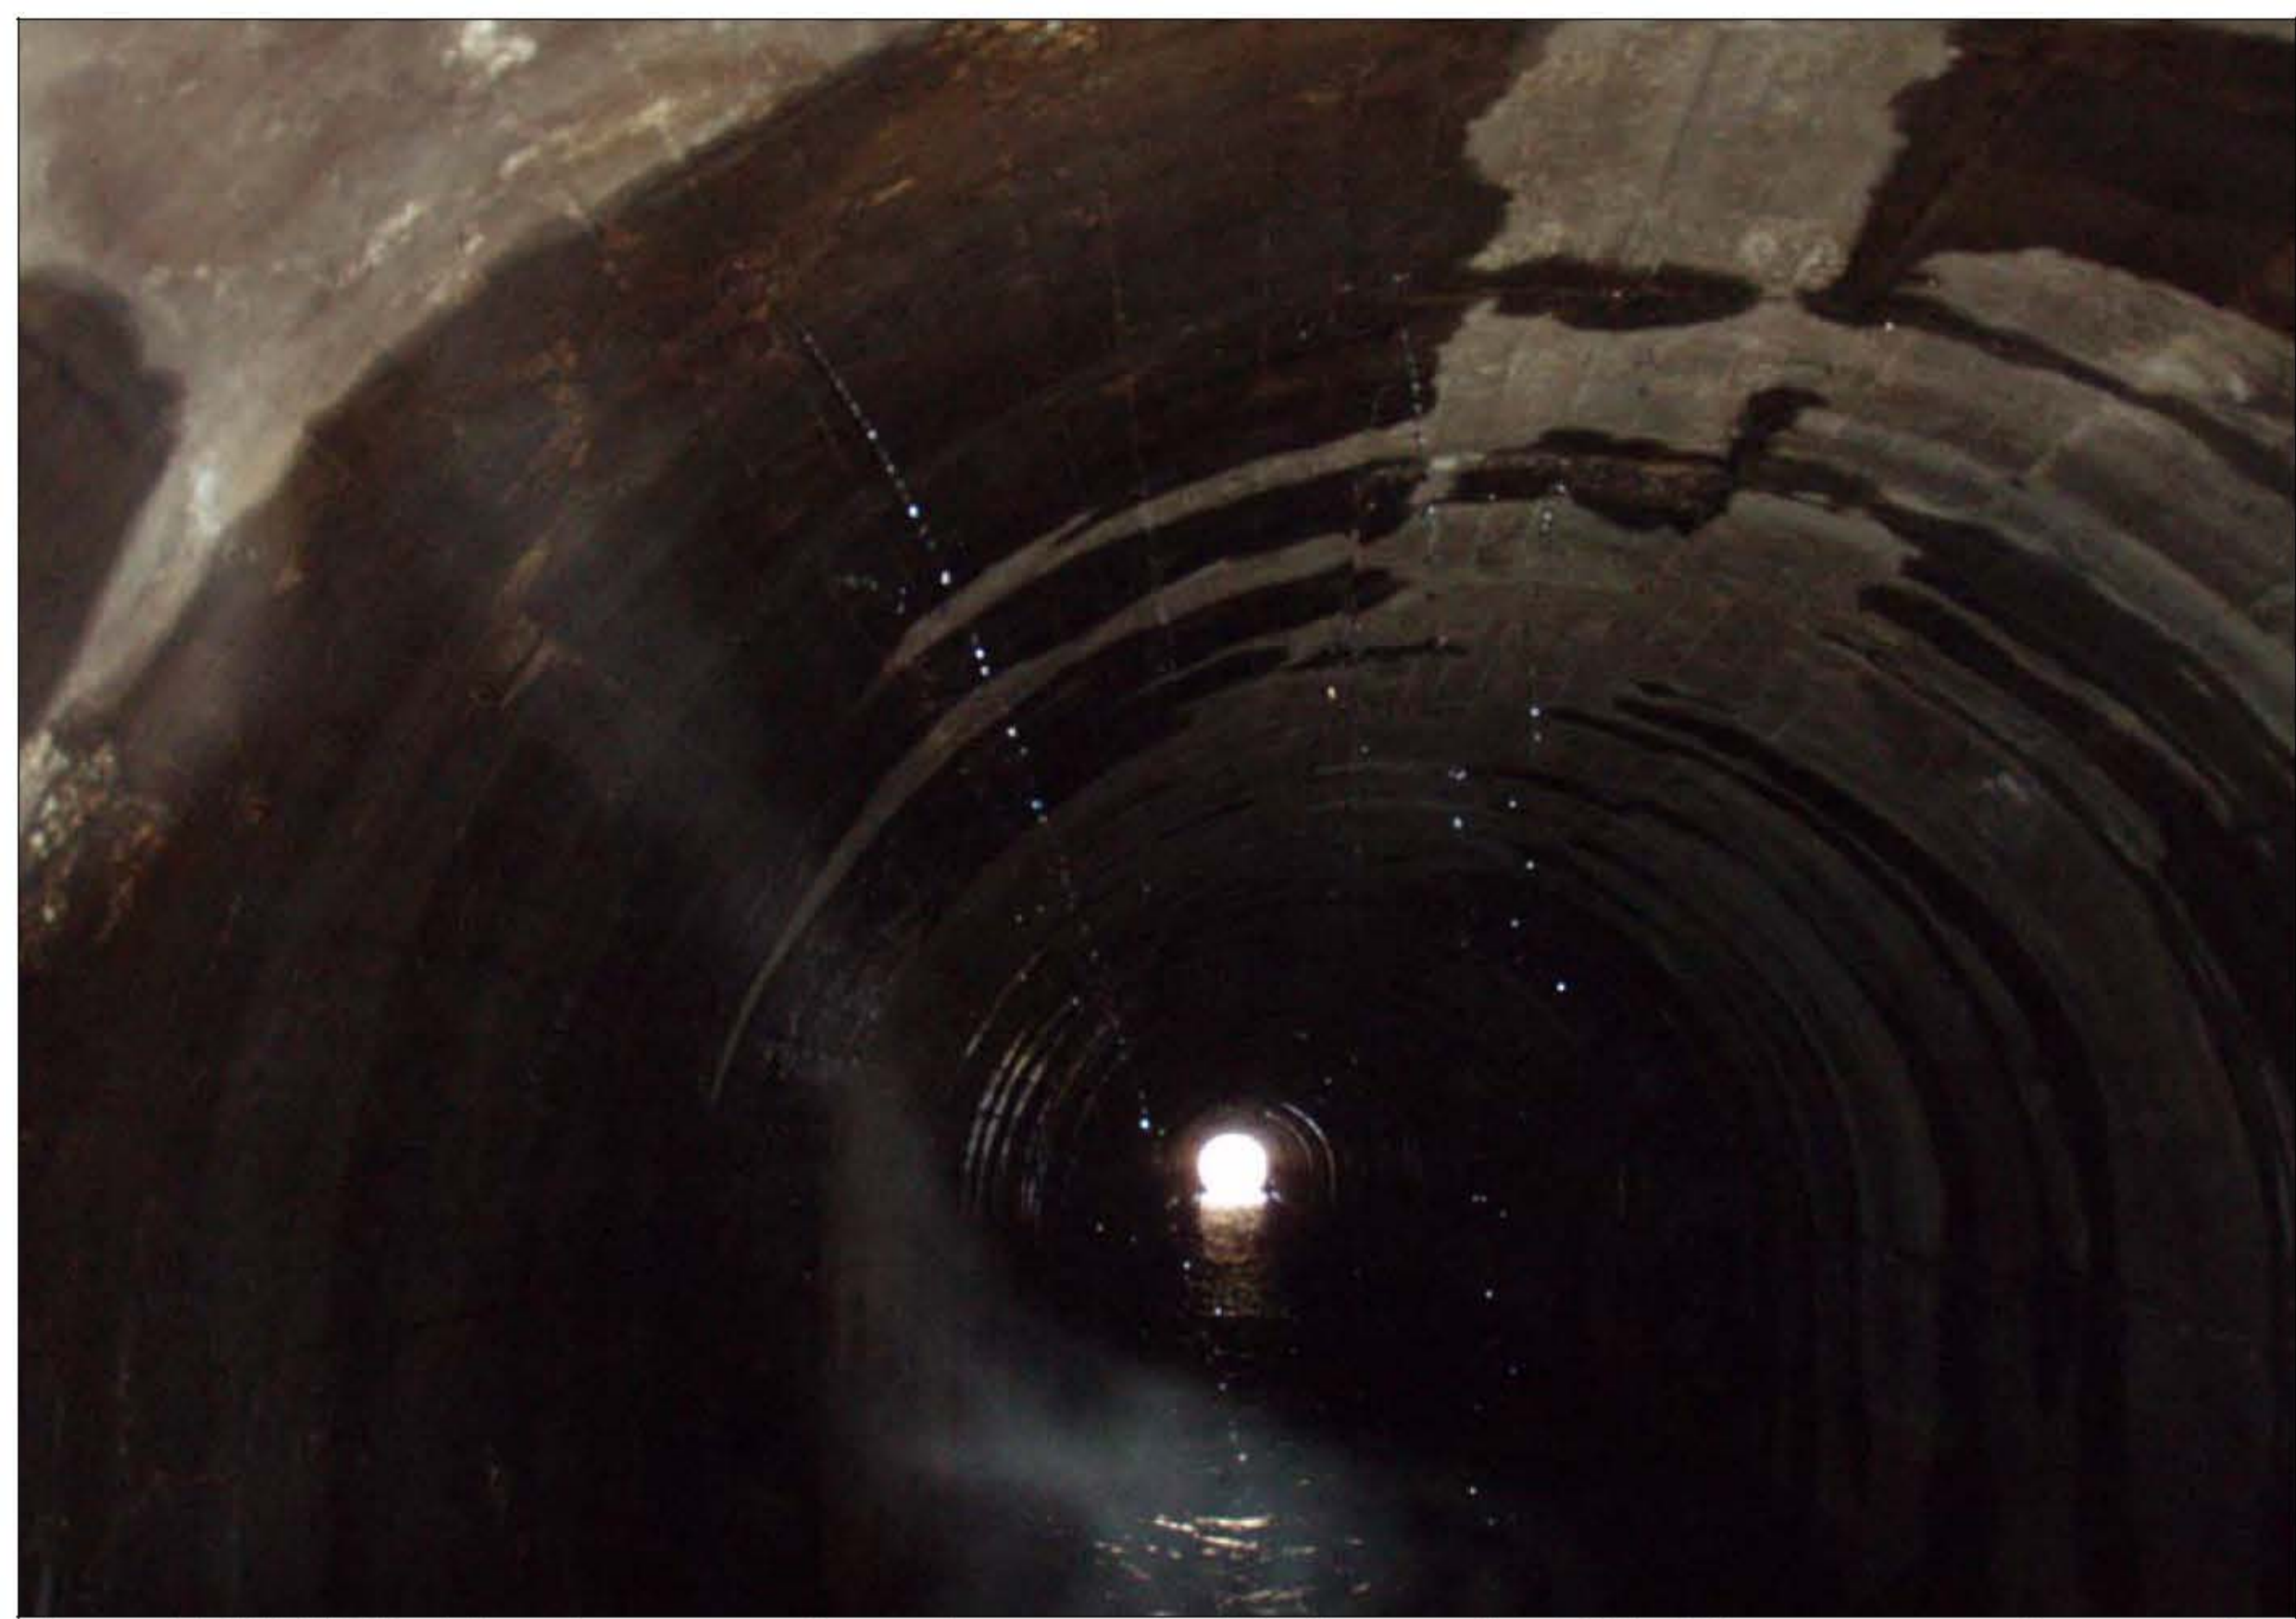
Figure 7 (11/5/08) - View from near the outlet gates inside the nominal 10'x10' concrete outlet tunnel looking downstream. Note the numerous weeps occurring through cracks and holes in the concrete.

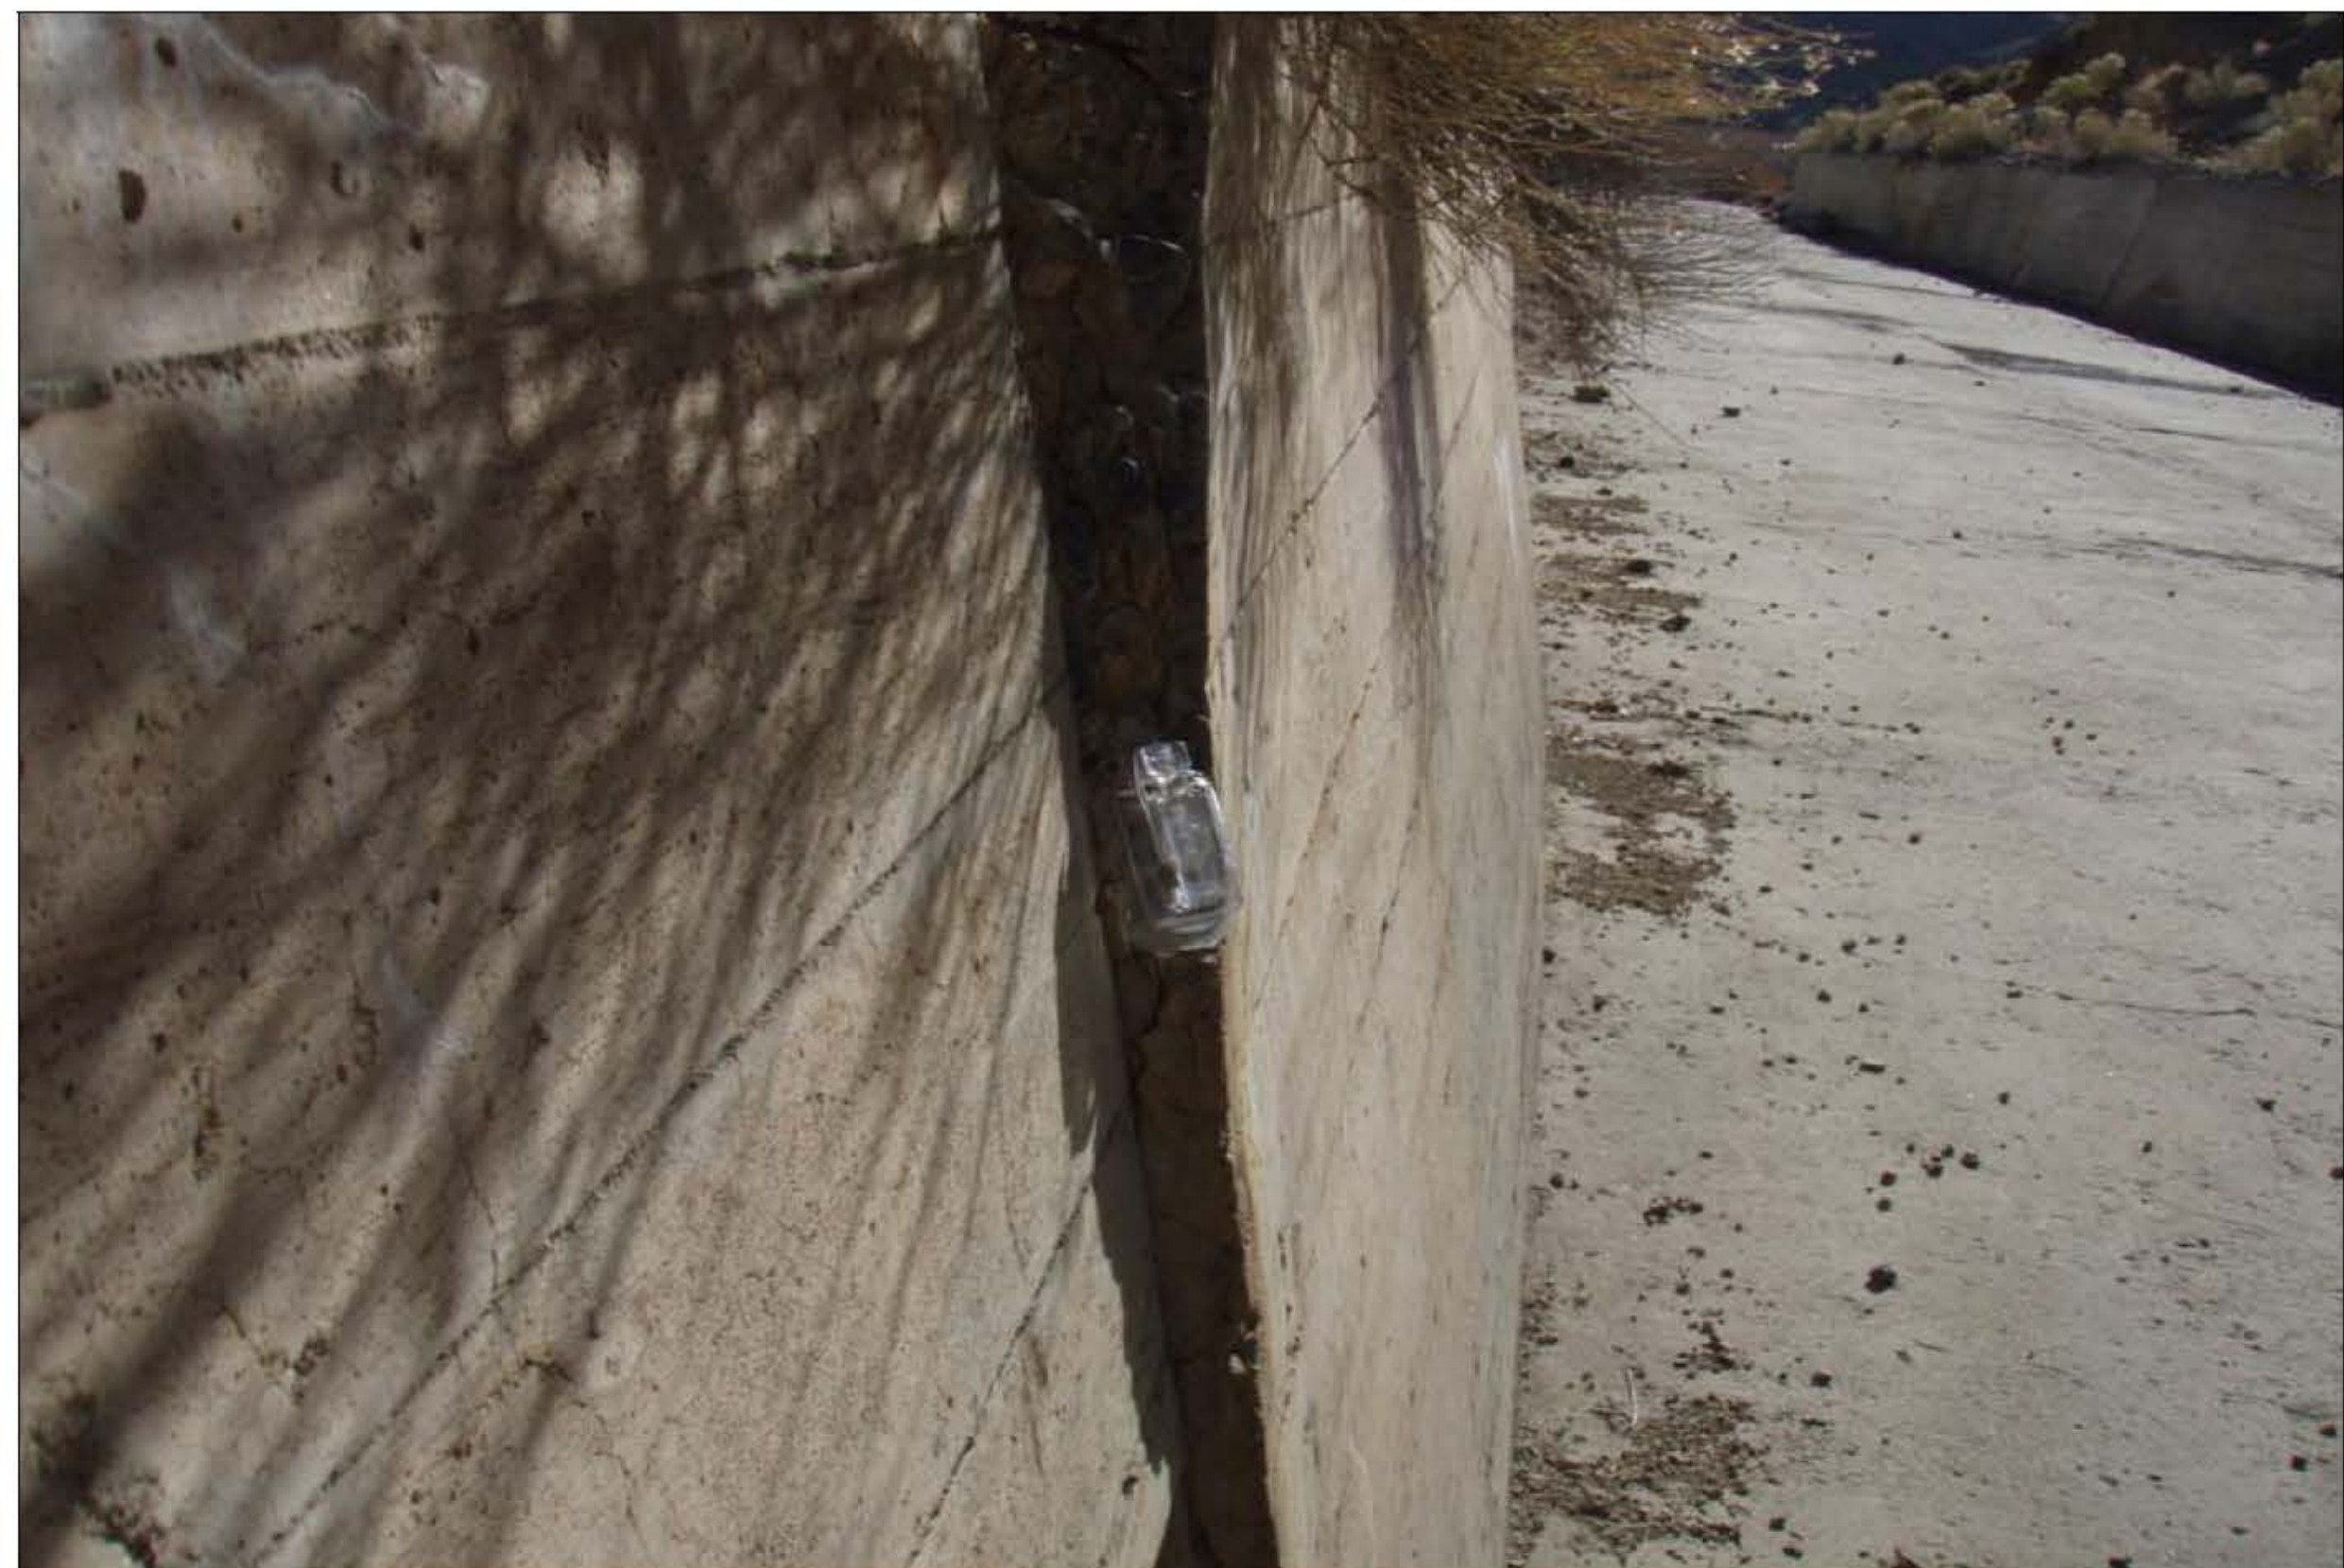
Figure 8 (11/5/08) - Emergency spillway showing the amount of offset between wall panels. These features should be periodically monitored and measured for continued movement.
