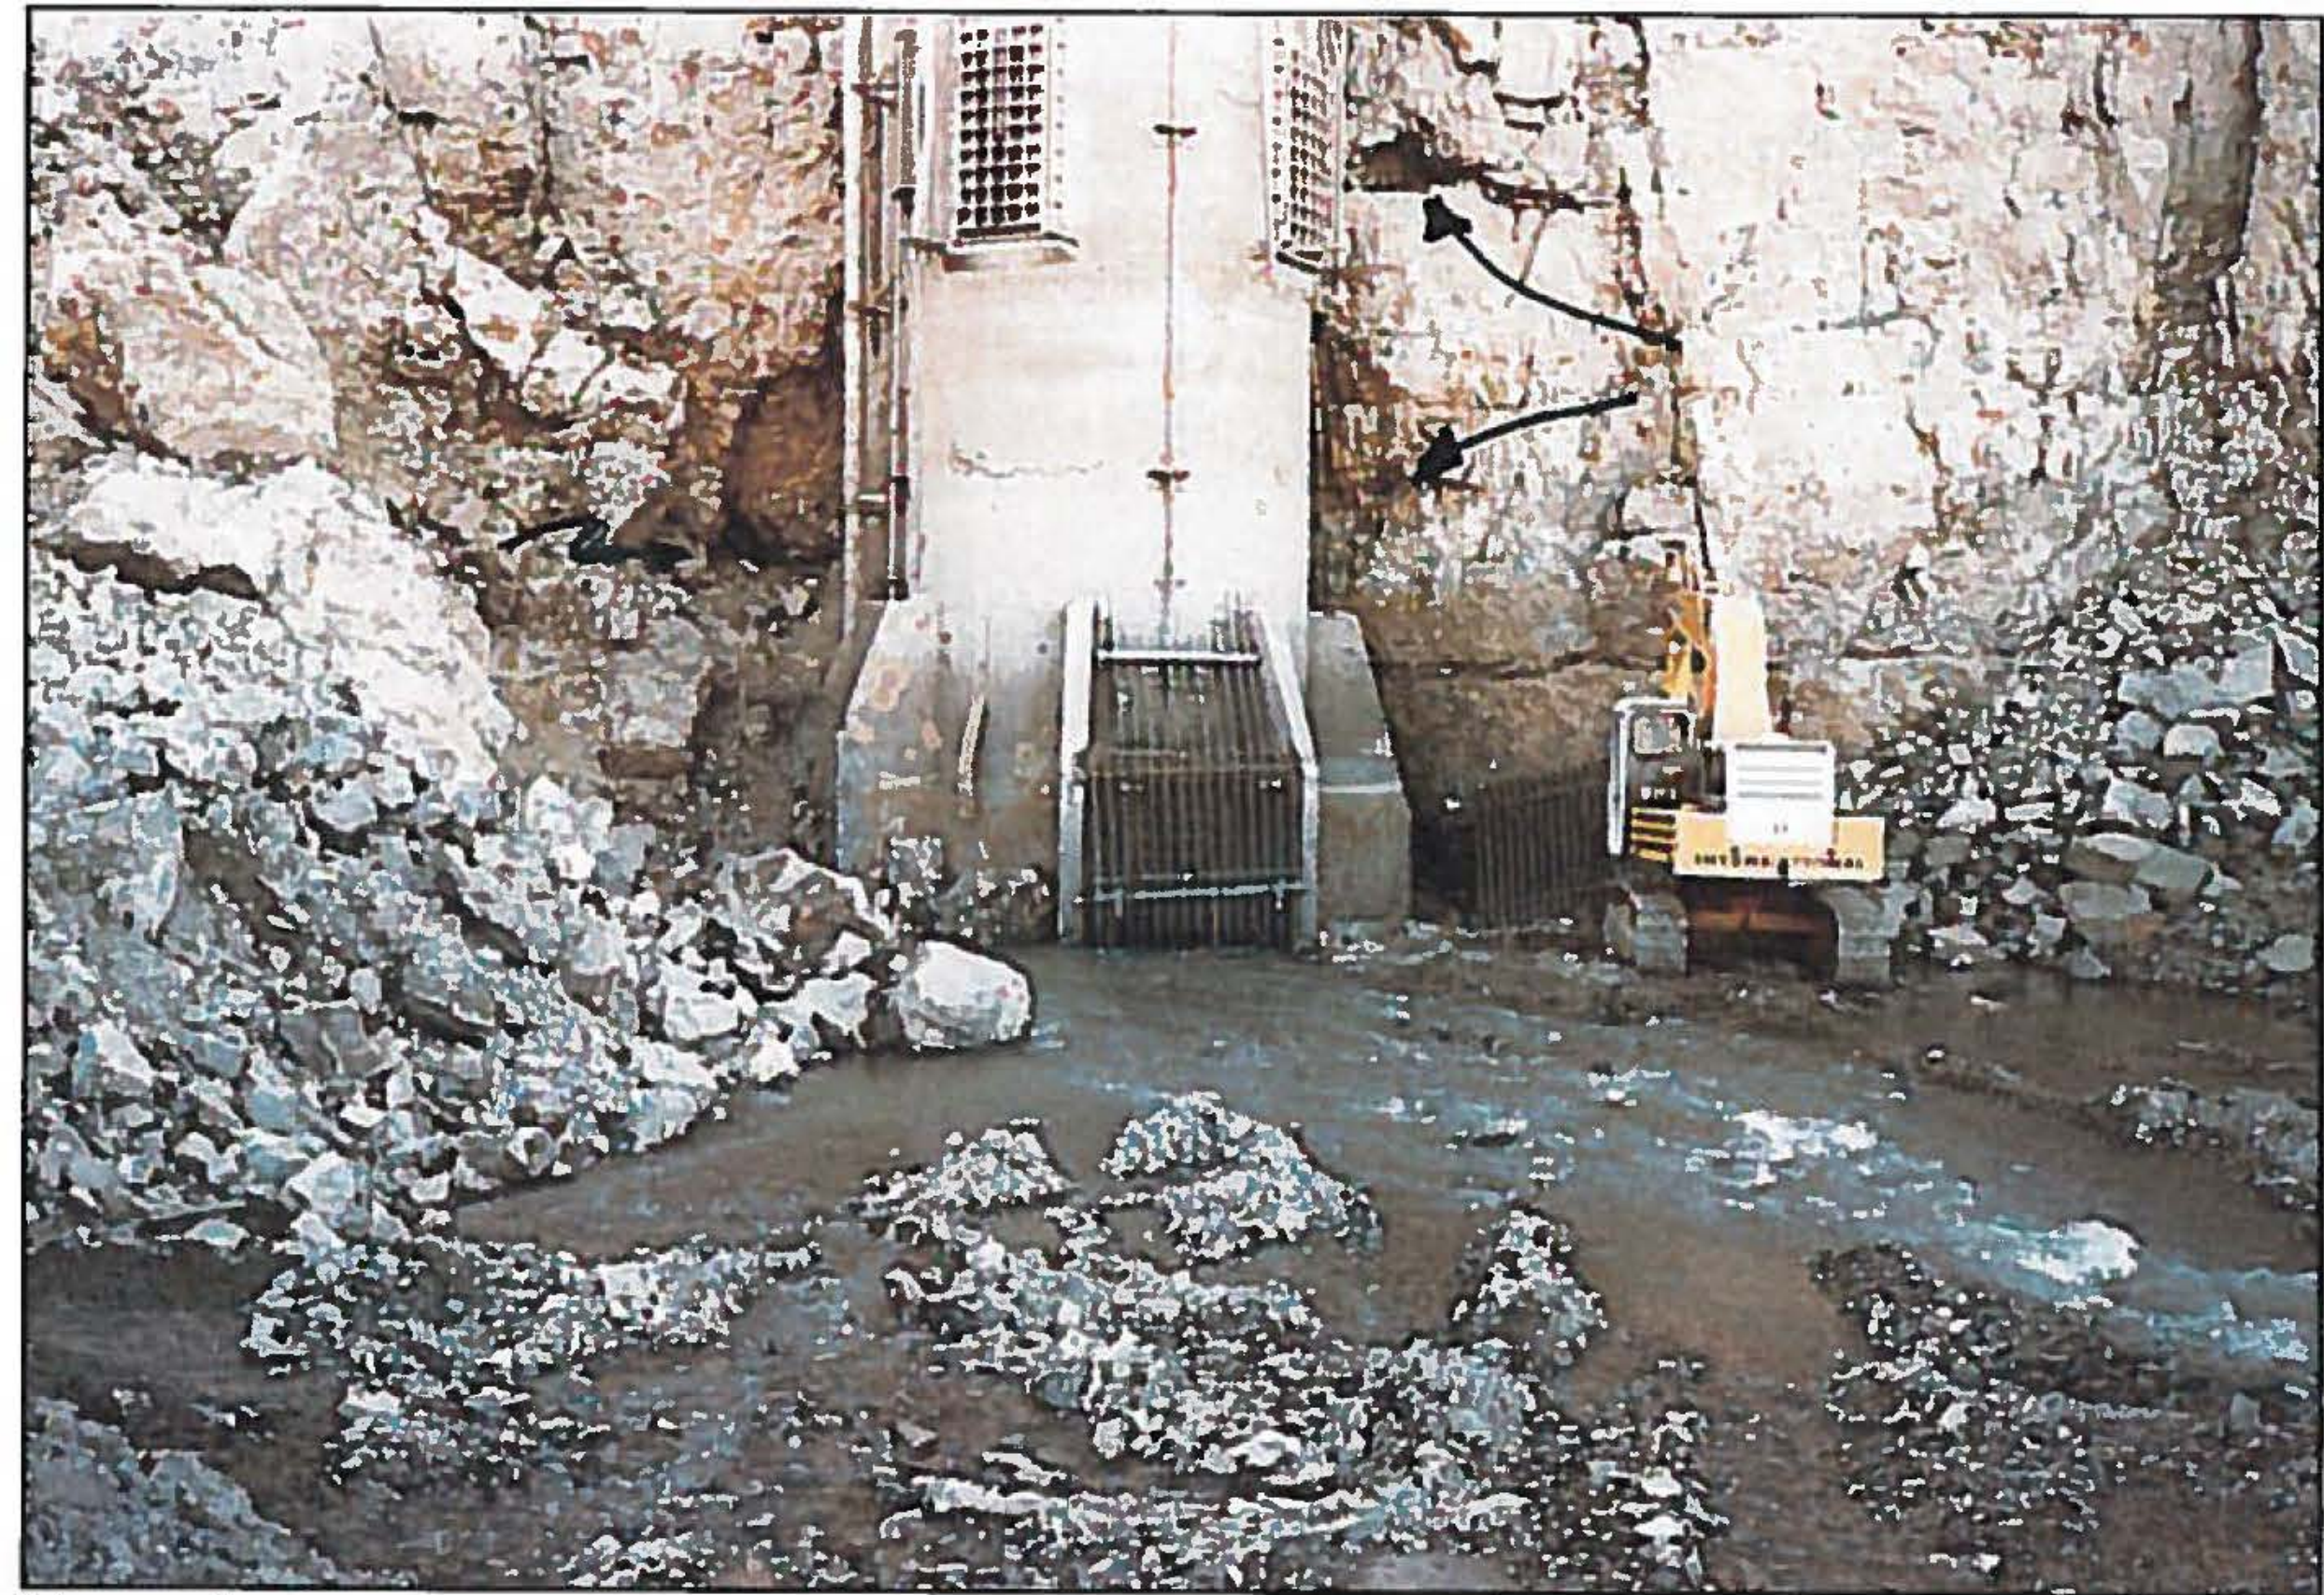
**Photo 3 (10-17-1985) - Compare against the 1955 photograph. As evidenced, the 1983 Mt. Borah earthquake and/or the subsequent blasting above the spillway (1984) apparently did indeed result in some displacement of the adjacent rock face; likely due to the different response of the foundation materials (alluvium vs. bedrock) beneath the Tunnel and Tower. The 1985 construction was reported necessary to remove rocks obstructing Gates #1 & #5**

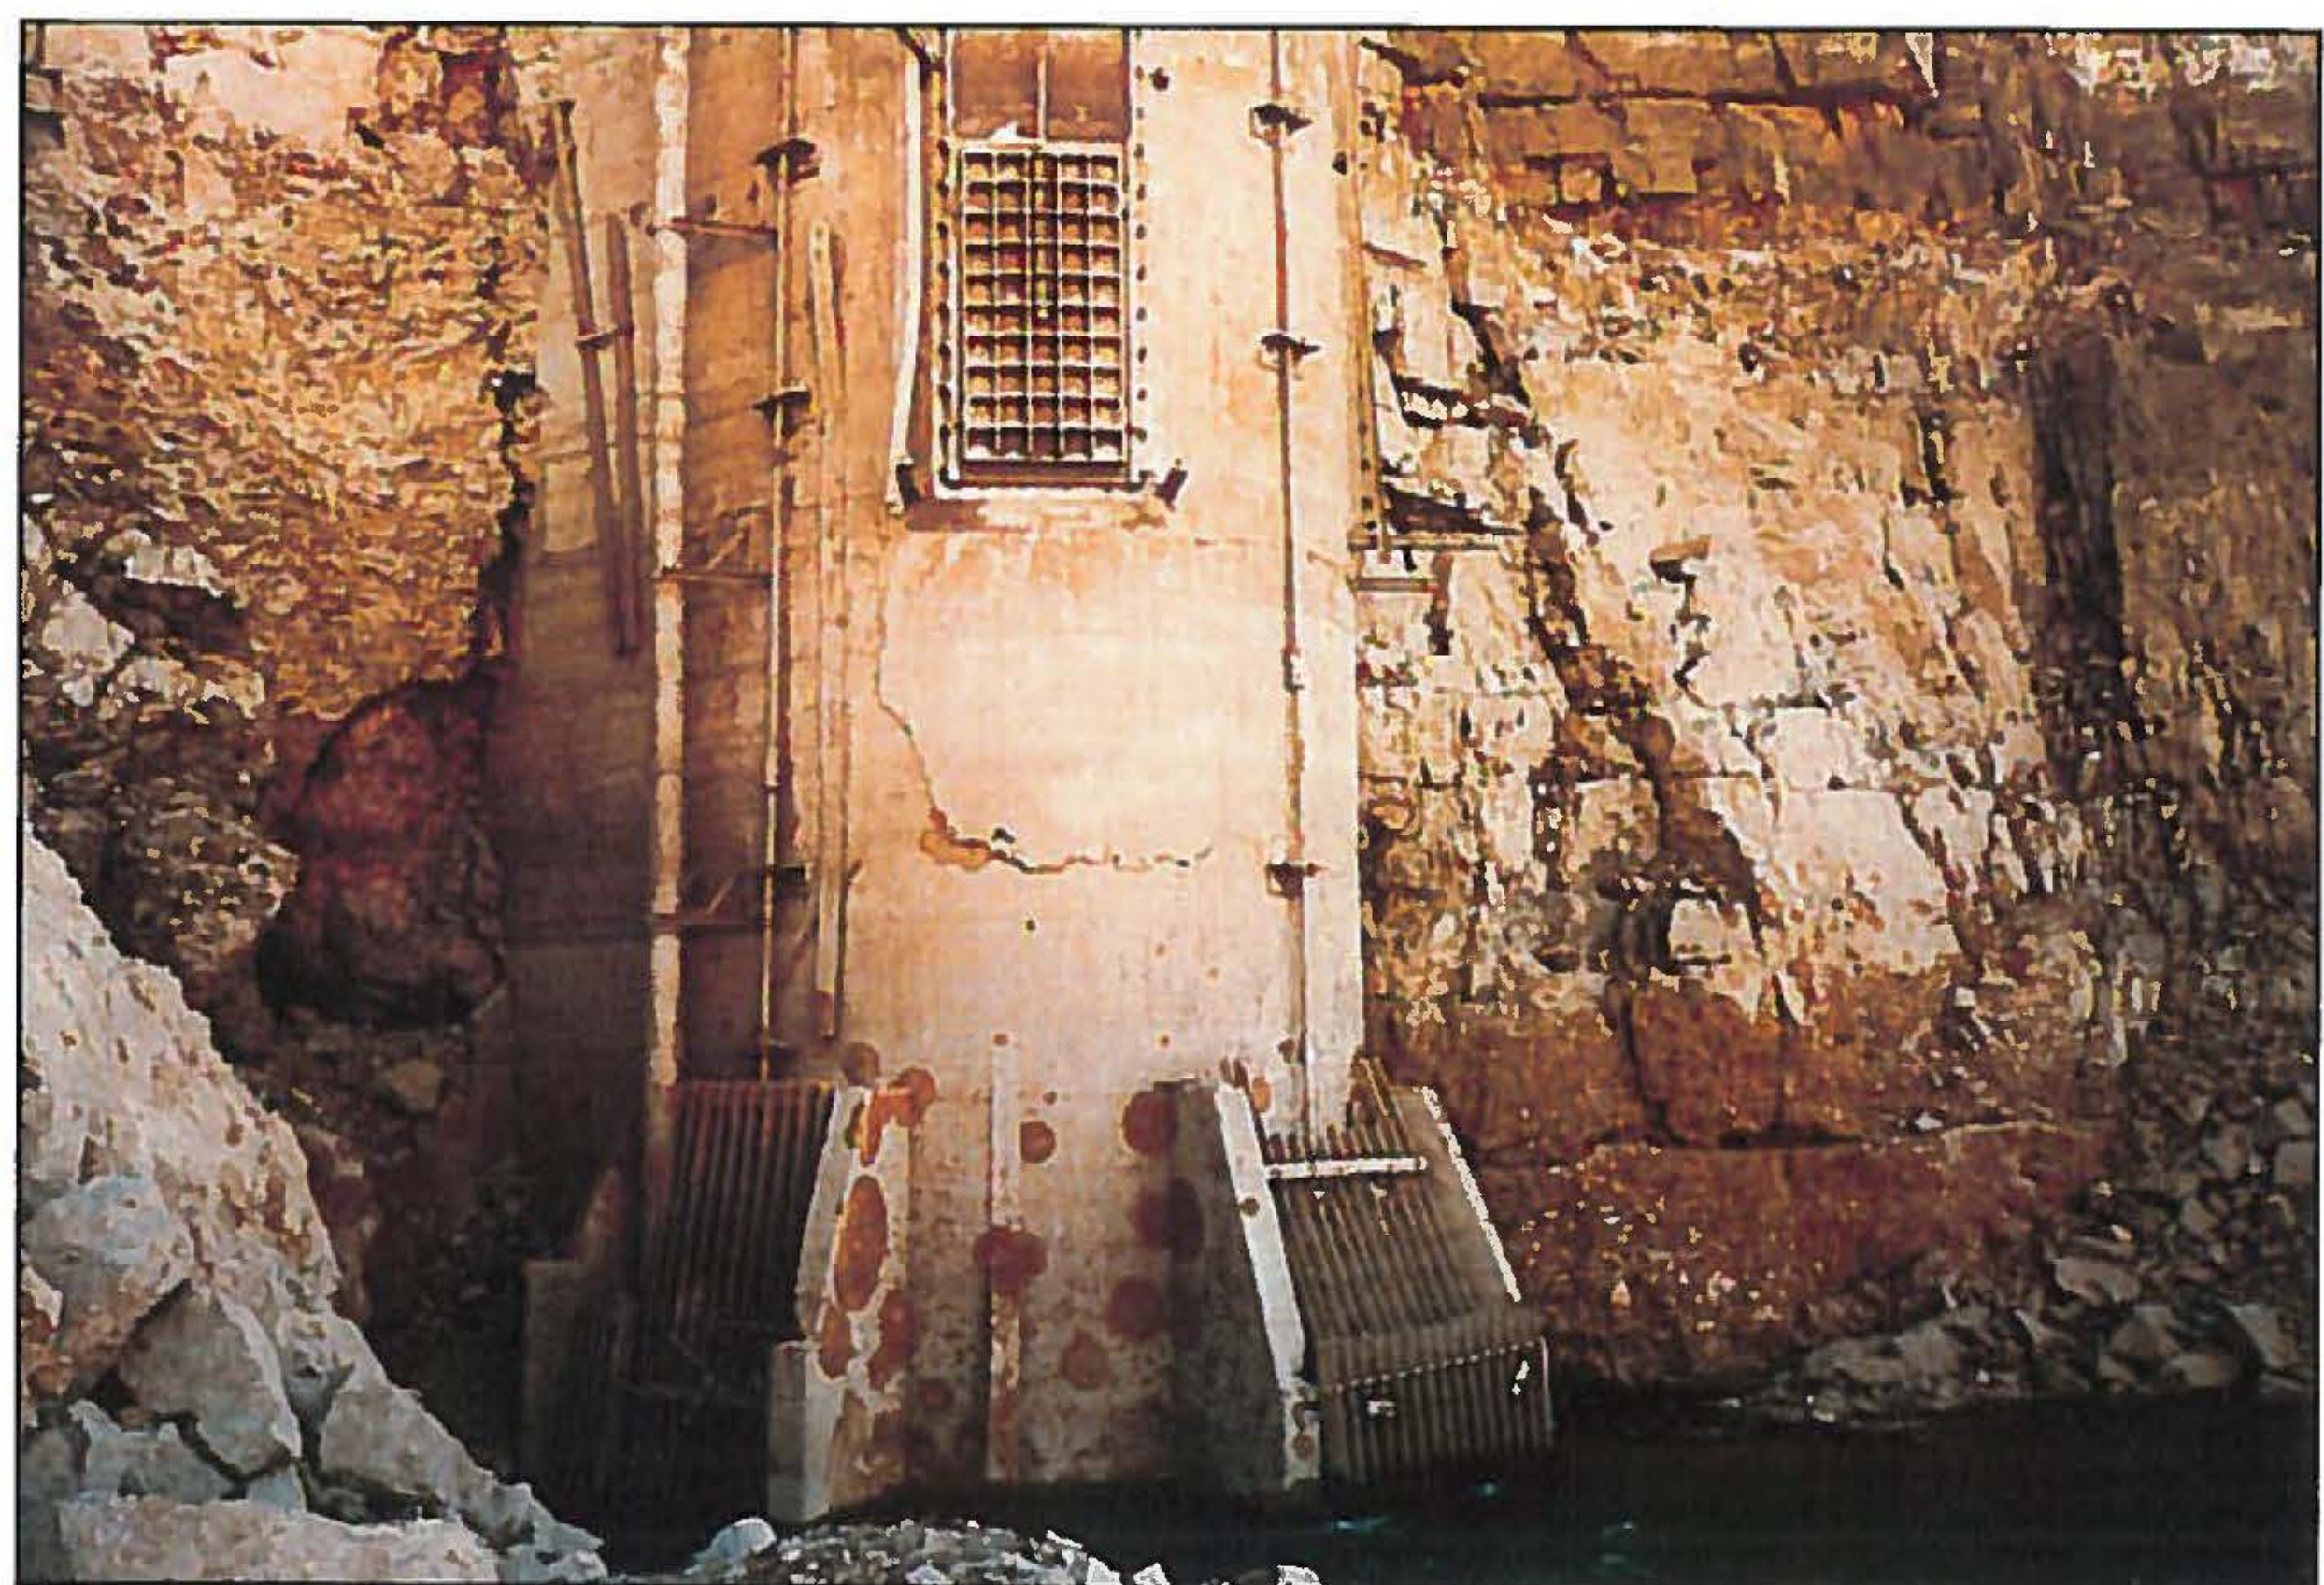
**Photo 4 (9/28/1988) - Similar view 2 years later. As reported, the reservoir was lowered to make repair to the concrete slab inside the gate chamber caused by rocks scouring the exposed surfaces.**
