Mackay Dam: Failure Far More Likely Than Previously Thought

Environmental Defense Institute

Tami Thatcher

September 2, 2022

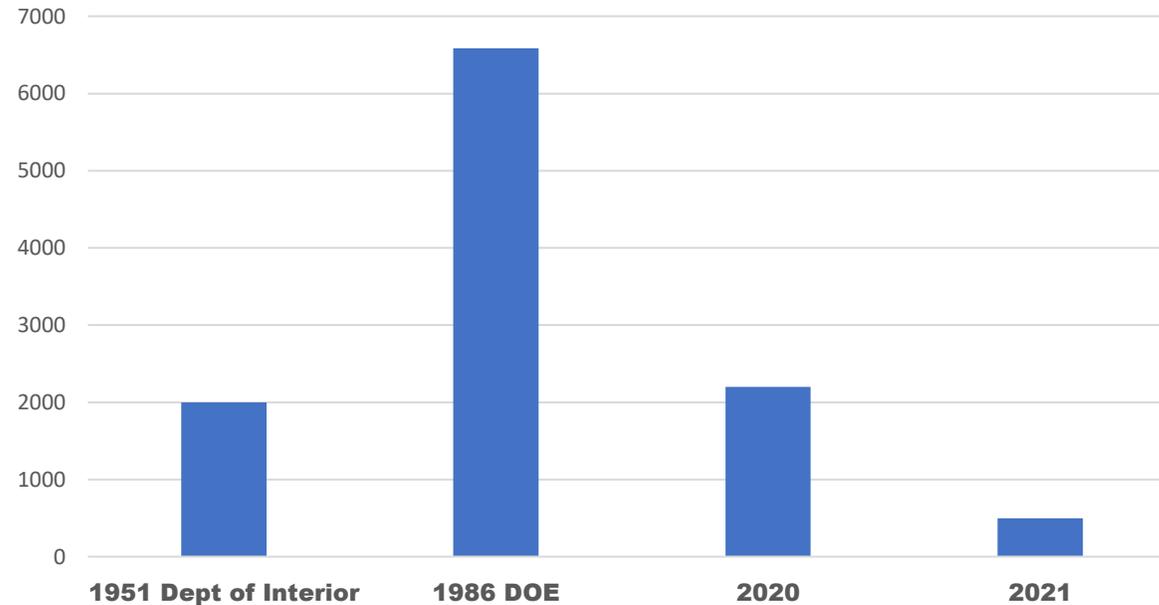
Mackay Dam
Evolving estimates of Spillway Capacity,
Cubic Feet Per Second

Mackay Dam spillway estimates

- 1951 Bureau of Reclamation estimated 2000 cfs
- 1986 Department of Energy funded study by Koslow and Van Haaften state that the Mackay Dam spillway capacity was 6,588 cfs (by assuming the entrance width rather than the narrower width and by ignoring that this estimate overtopped the spillway walls)
- 2020 McMillen Jacob estimate spillway capacity of 2,200 cfs (using 24-ft spillway width rather than 75-ft entrance width)
- 2021 McMillen Jacob study concluded that the degraded condition of the spillway walls would cause failure of the spillway and then the dam if spillway flows sustained at 500 cfs (or 50-year flood)
