# Environmental Defense Institute

September 2022

### Mackay Dam Failure, Far More Likely Than Previously Thought – No Apparent Action by State and Federal Agencies

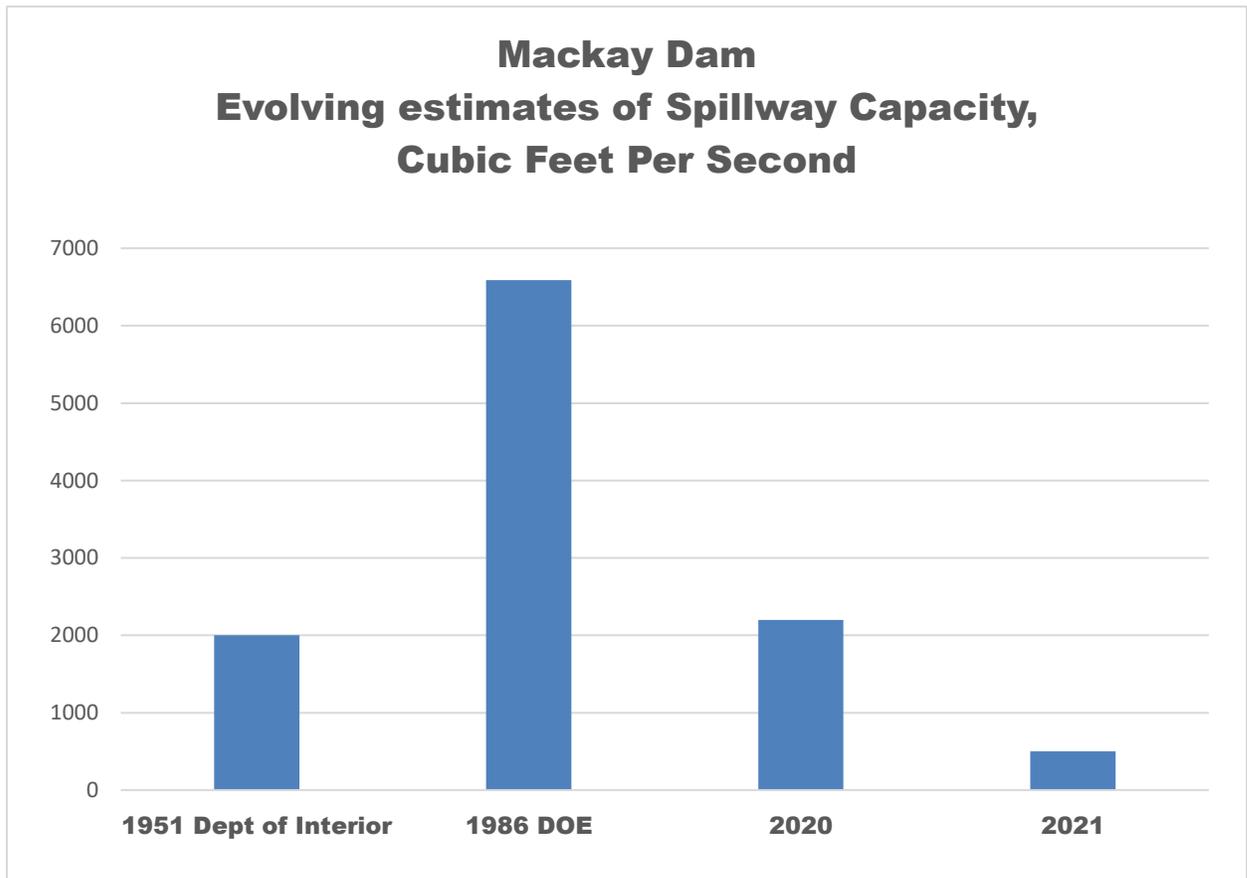
The current release capability of the Mackay Dam now at the risk of failure at between a 50-yr to 25-year return interval flooding would be an “anticipated” event with an annual probability of failure as high as 1-in-25 per year or  $4.0E-2$ /yr. **The reduced spillway capacity means that the Mackay Dam has a very high failure rate not normally accepted for a high hazard dam.**

This estimate takes into account normal gate positioning that would normally be positioned to pass 2000 cfs through the outlet and with reservoir attenuation would allow an inflow to the reservoir of 4,380 cfs (McMillen Jacobs 2021, Appendix A, page. 16). Movement of the gates is unreliable and access to the outlet tower would not be possible when the spillway walls have failed or overtopped. With reservoir attenuation, the 50-yr flood would fail the dam. At 95 percent confidence, the recurrence interval is only about 25-year, according to the graph in Appendix A. Assumptions made to justify the 50-yr flood to fail the dam include favorable timing of the precipitation as occurred in 2017, which was spread over three peaks.

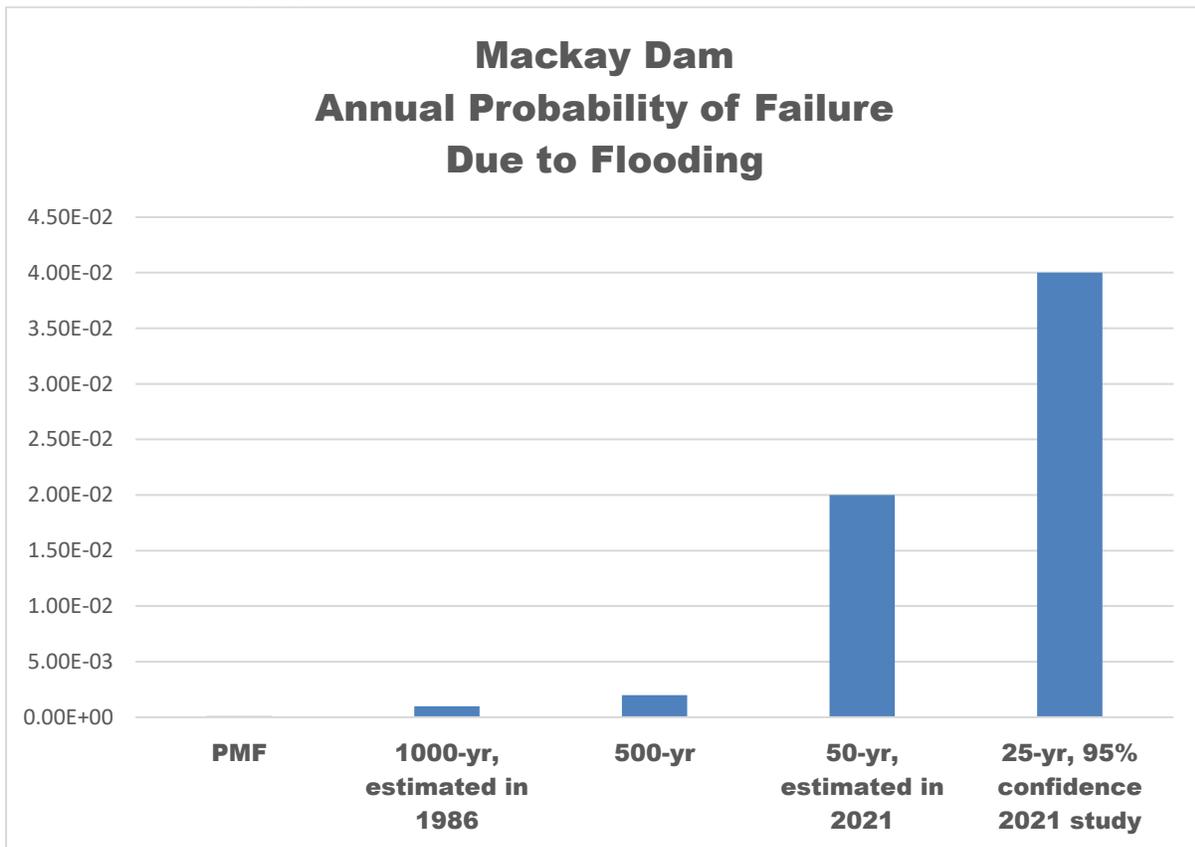
- 1986, 1000-year flooding was not expected to fail the dam. But exceeding the release capability of 9548 cfs, with 2,960 cfs from the outlet tunnel and 6,588 cfs from the spillway, would fail the dam. The annual failure probability due to greater than 1000-year flood is less than 1.0E-3 failures/year
- 2020 or 2021, 500-year flooding of 5,210 cfs exceeded the release capability and would fail the dam at 2.0E-3 failures/year
- 2021, 25-year to 50-year flooding exceeding the release capability of 2500 cfs would fail the dam at 4.0E-2 to 2E-2 failures/year. Higher flood inflows into the reservoir can be accommodated, attenuating the higher inflows, until the dam fails but this depends on operating decisions prior to and during the onset of high inflows.

What had been “unlikely” has become an “anticipated” and one that poses a higher likelihood of failure than may have been assumed in previous nuclear safety analyses and may also now be higher than allowed in hazardous waste permits at the INL, see Table 5.
