The Truth about the SL-1 Accident — Understanding the Reactor Excursion and Safety Problems at SL-1

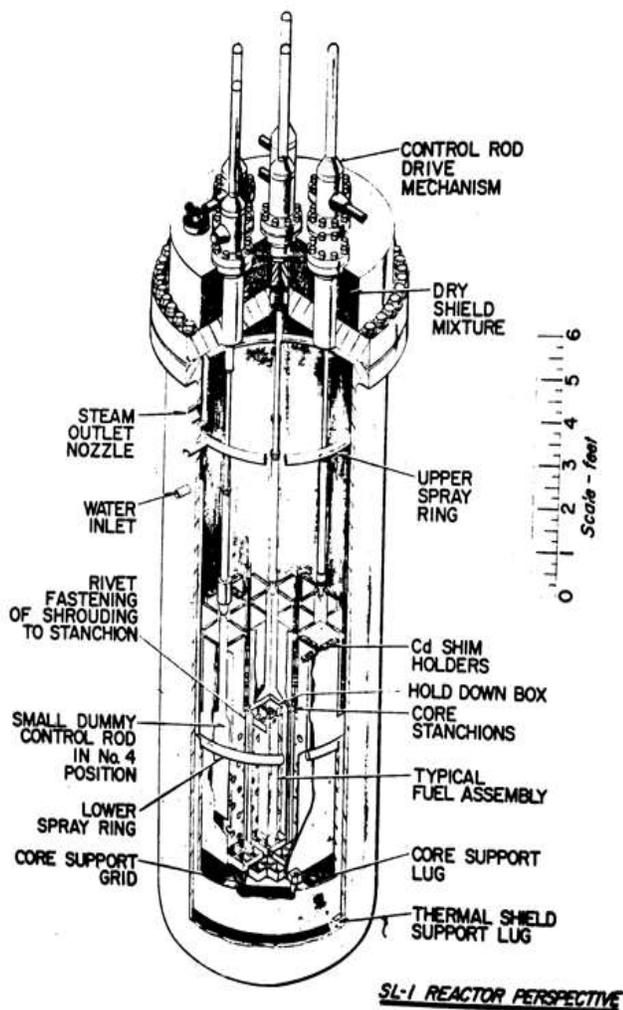
The SL-1 core contained 14 kg of 93 percent enriched Uranium-235 in 40 aluminum fuel assemblies. Control of the reactor used 5 cruciform-shaped cadmium control blades raised and lowered by control rods. There were 4 outer (shim) control rods, labeled No. 1, 3, 5 and 7, and one center control rod, No. 9, to regulate reactor power. In addition to the control rods, burnable poison was added in the form of aluminum-boron strips, both half-length and fuel length, that were spot welded to the sides of the fuel assemblies. See Figure 1.

Figure 1. SL-1 Reactor perspective from IDO-19311.
