The Truth about the SL-1 Accident — Understanding the Reactor Excursion and Safety Problems at SL-1

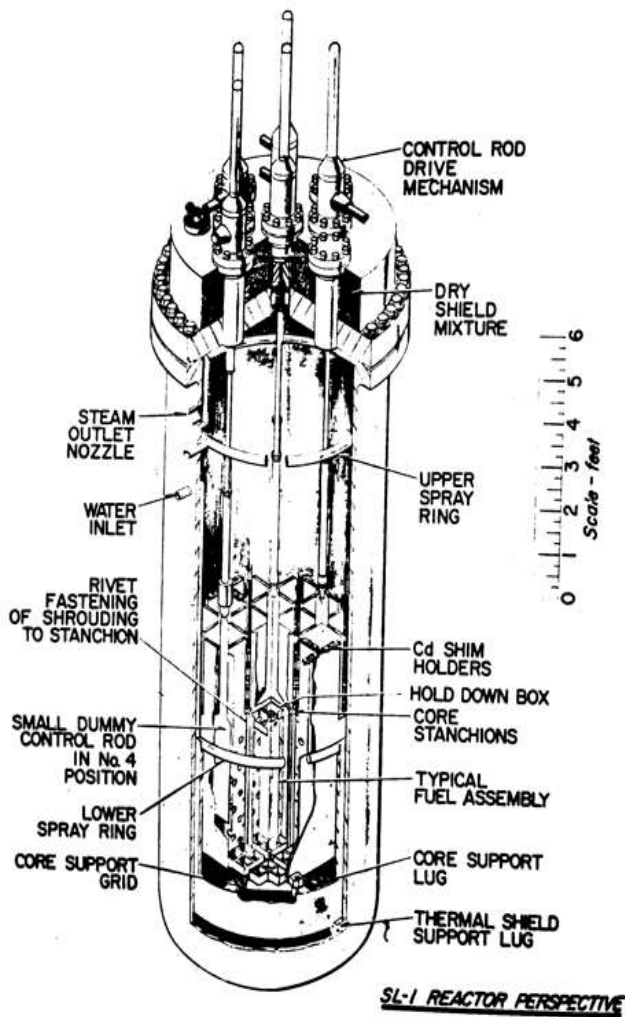
Figure 1. SL-1 Reactor perspective from IDO-19311.

The SL-1 core contained 14 kg of 93 percent enriched Uranium-235 in 40 aluminum fuel assemblies. Control of the reactor used 5 cruciform-shaped cadmium control blades raised and lowered by control rods. There were 4 outer (shim) control rods, labeled No. 1, 3, 5 and 7, and one center control rod, No. 9, to regulate reactor power. In addition to the control rods, burnable poison was added in the form of aluminum-boron strips, both half length and fuel length, that were spot welded to the sides of the fuel assemblies. See Figure 1.
